Mold Assessment

of the school located at
248 North Samsula Drive
New Smyrna Beach, Florida 32168

REF: Mold Assessment

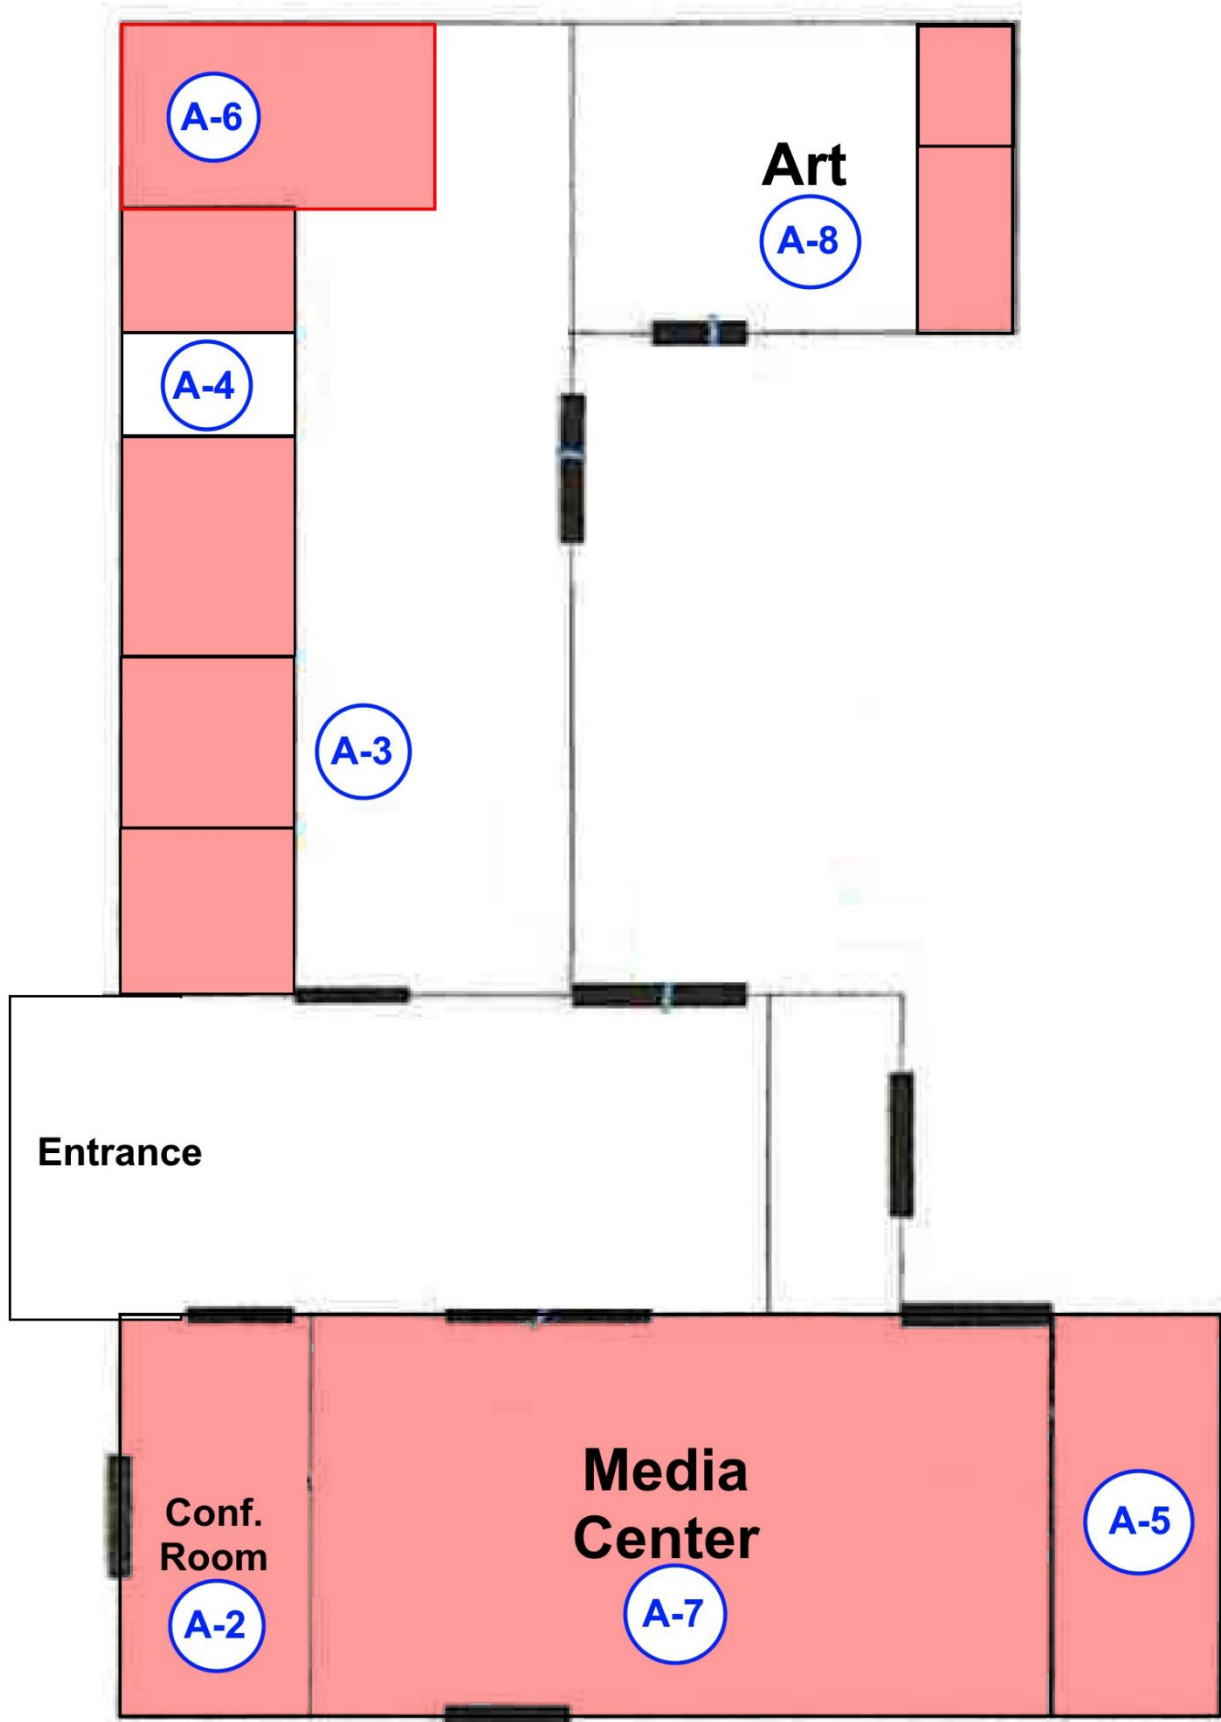
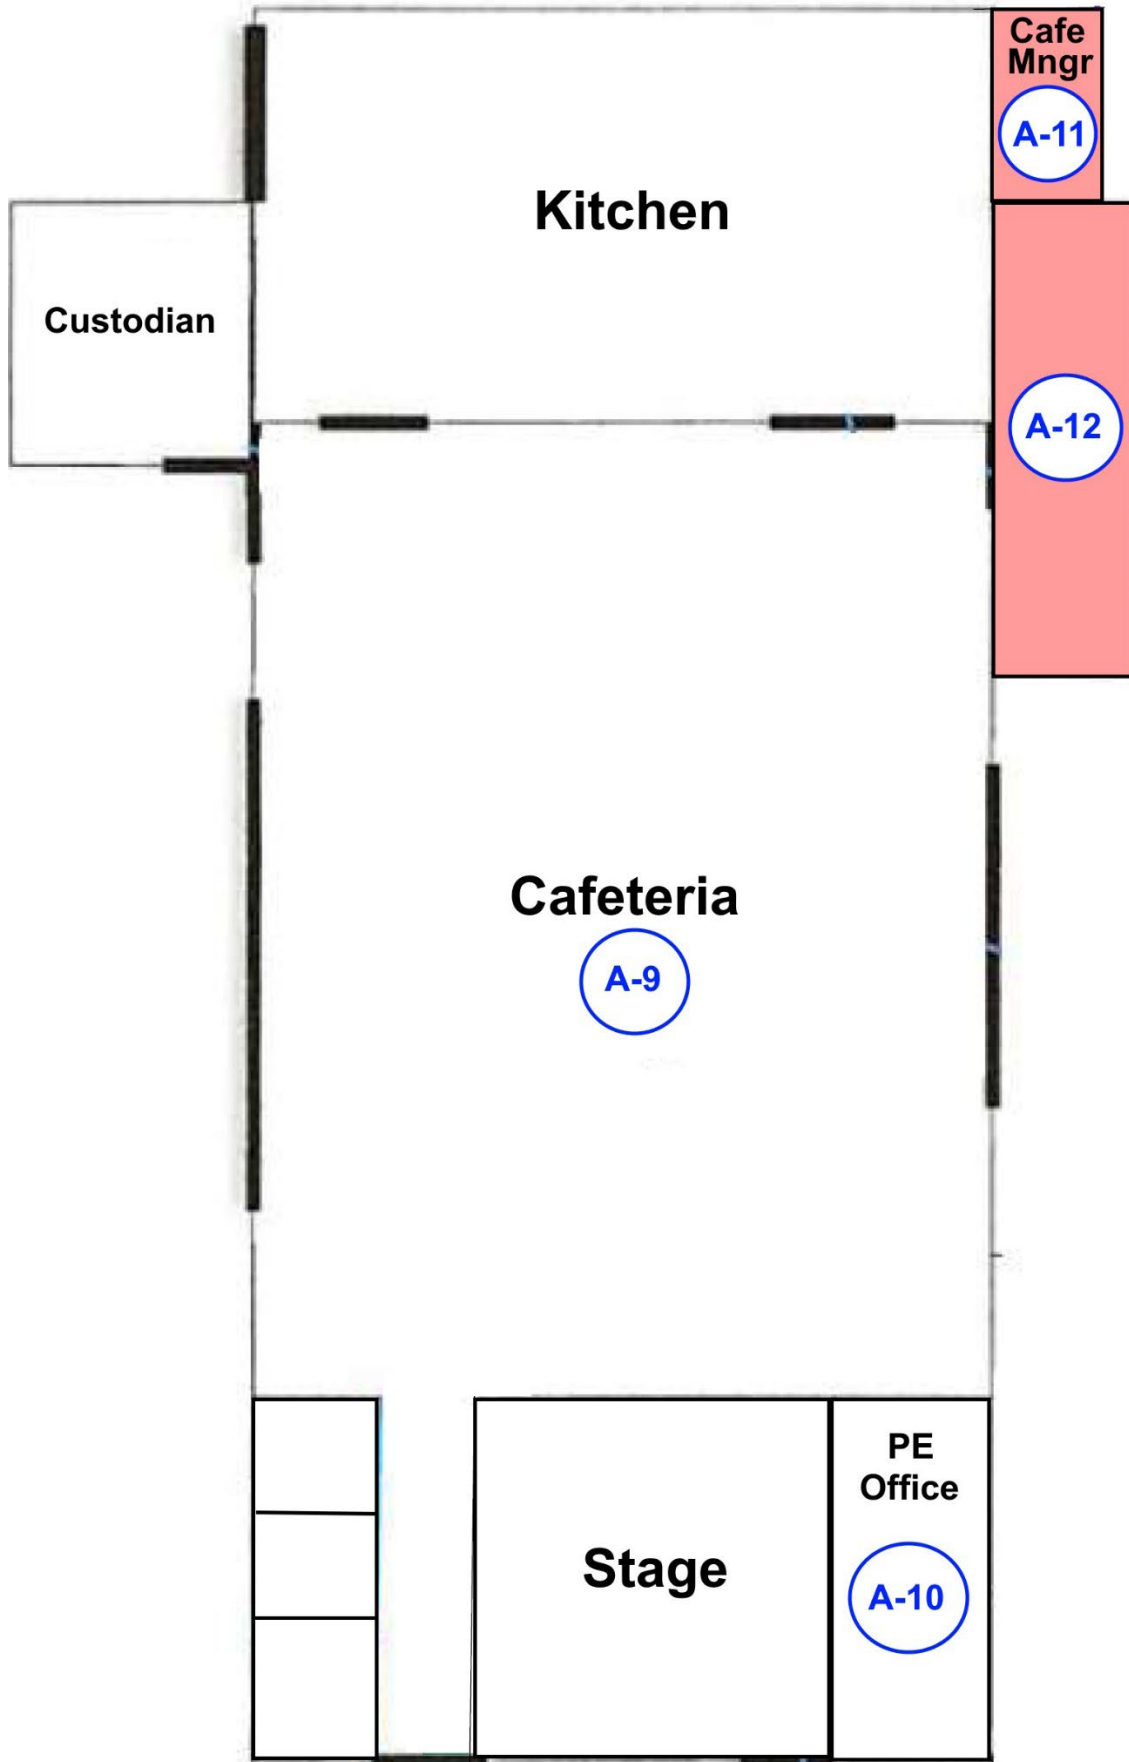
Building 1

There was no indication of mold contamination on any of the belongings or building materials that would merit building 1 conference room, building 1 media room inclusive of the back office, the southeast offices, and to the offices to the west of the kitchen in building 3 mold remediation or contents pack out. EMS reported no visible mold in any of these areas. There was no elevation of mold in any of the samples collected by EMS. We do not see the need to pack-out the areas and clean all contents. We did not see any indication of the need during our assessment and the samples collected by EMS support that opinion.
