LIMITED INDOOR AIR QUALITY (IAQ) and MICROBIAL ASSESSMENT REPORT

Project Location:

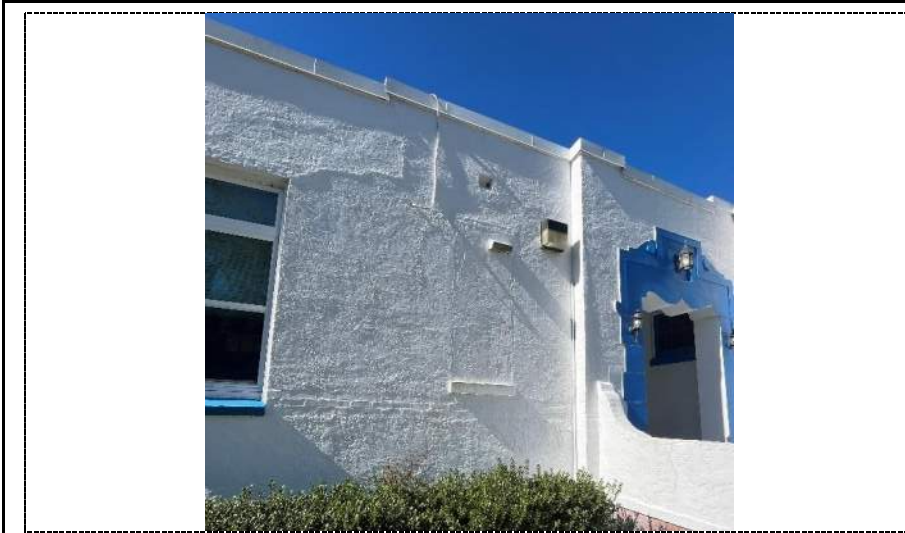
Photo 3 -
Infill and exterior
cracking on front
elevation-building
1.

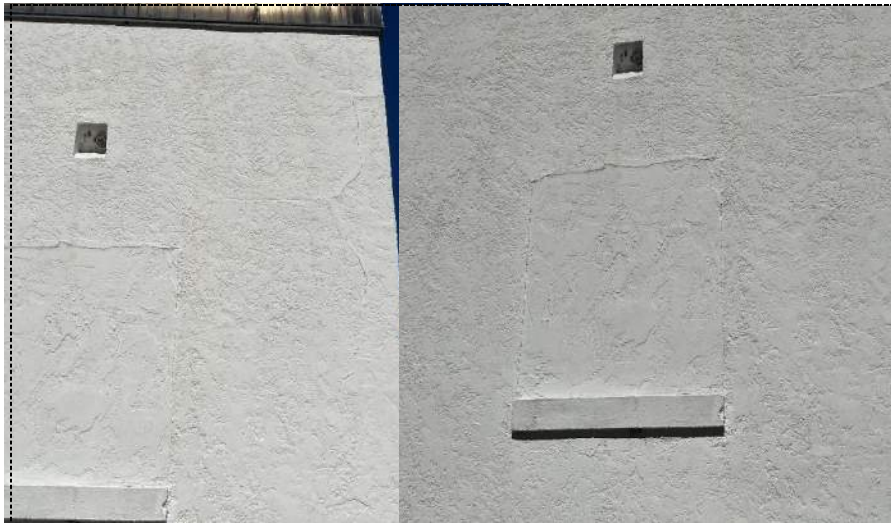
Photo 4 -
Infill and exterior
cracking at
Southeast corner
of building 1 break
room (interior
damage).

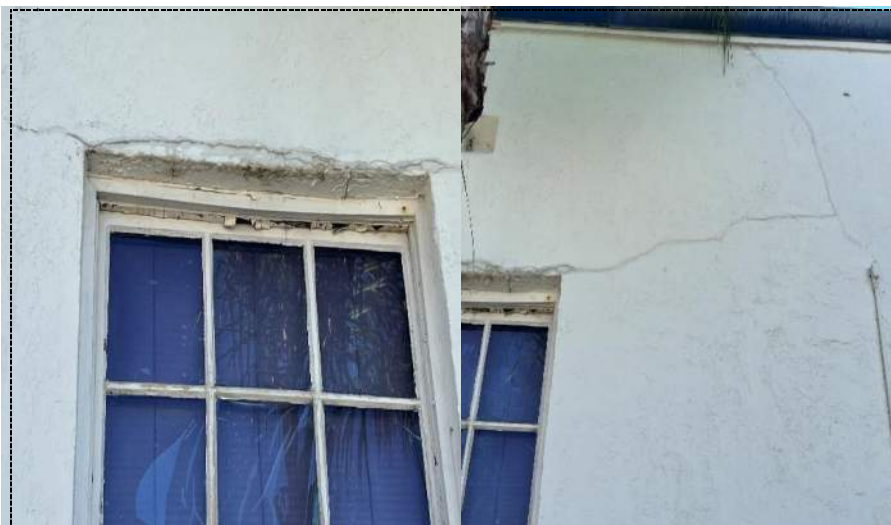
Photo 5 -
Exterior wall
cracking and
window seal
deficiencies-
building 1.

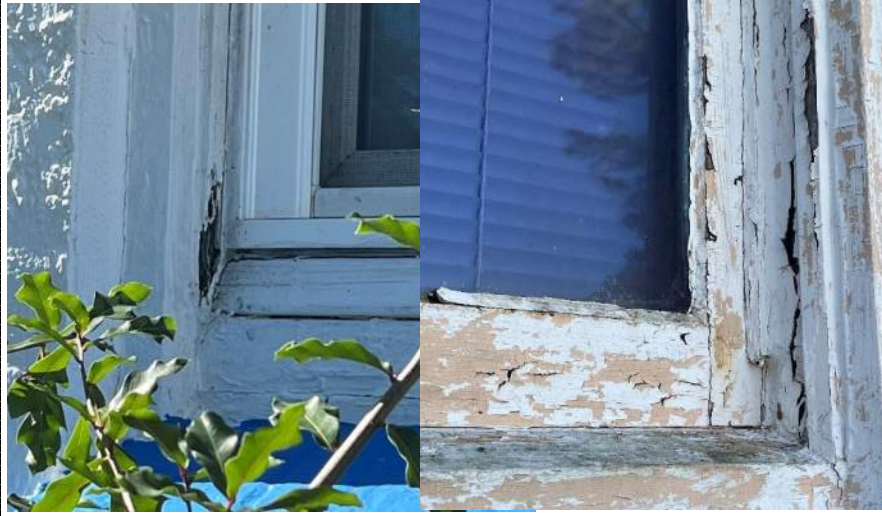
Photo 6 -
Window seal
deficiencies and
wood rot- building
1.

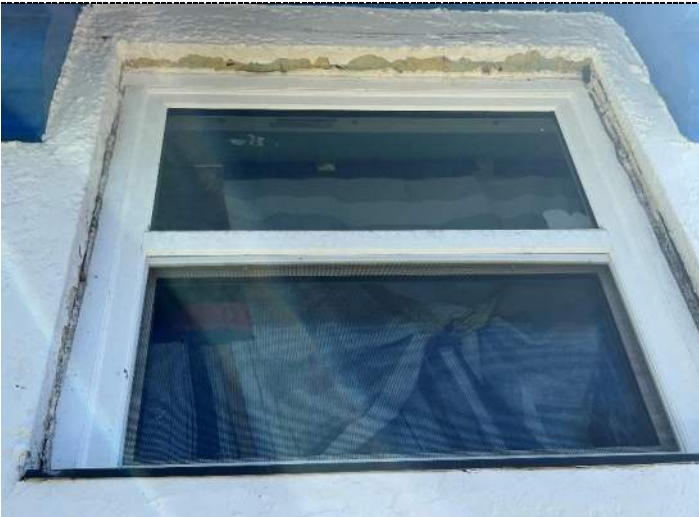
Photo 7 -
Window seal
deficiencies and
wood rot-building
1.

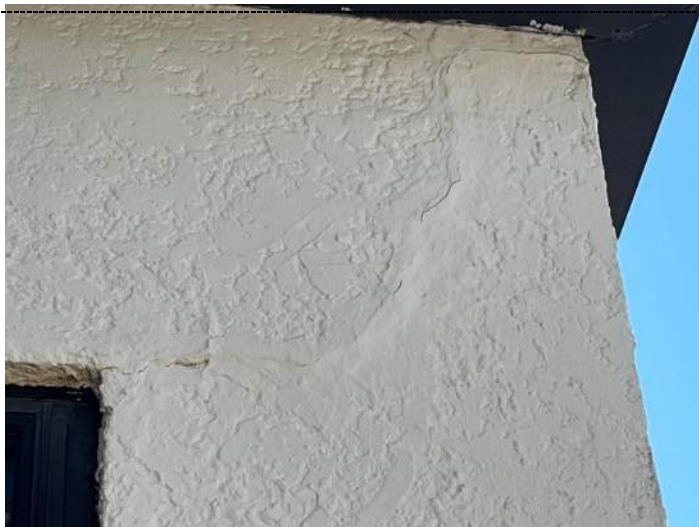
Photo 8 -
Exterior cracking
on main office
exterior-building 1.

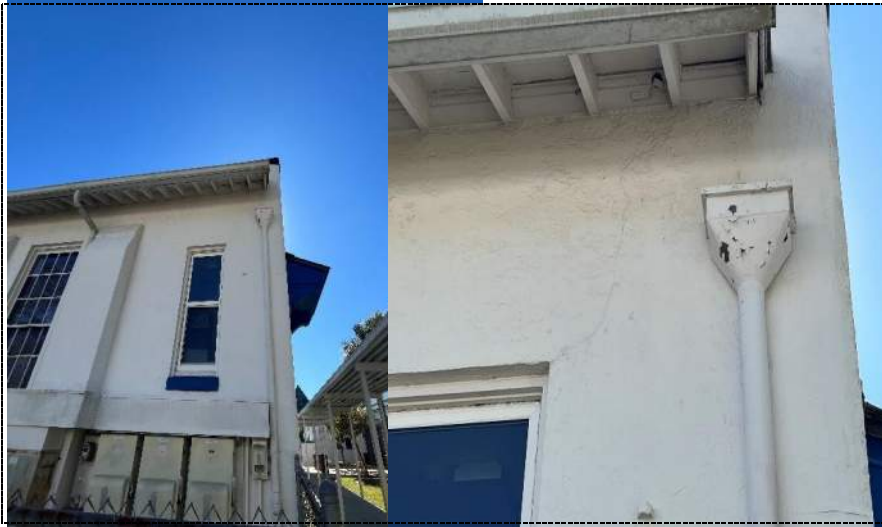
Photo 9 - Exterior cracking on main office exterior-building 1.

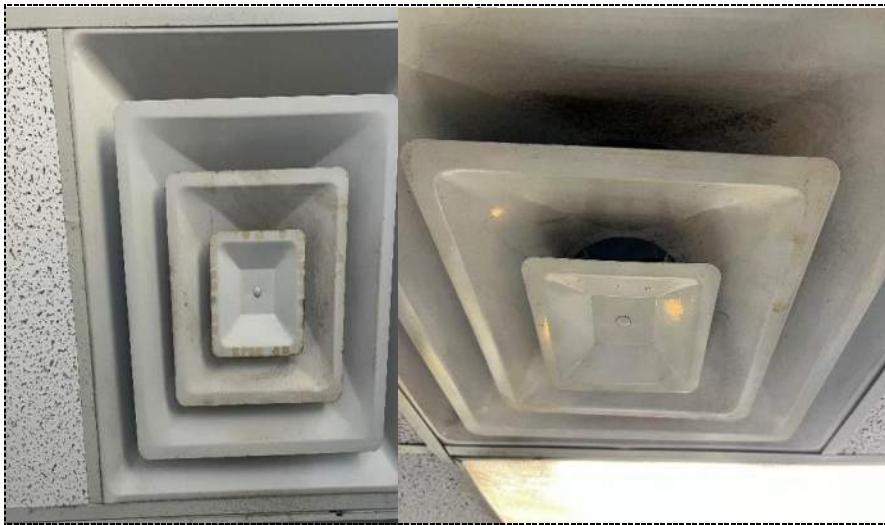
Photo 10 - Casting and possible microbial amplification on diffusers throughout admin area-building 1.

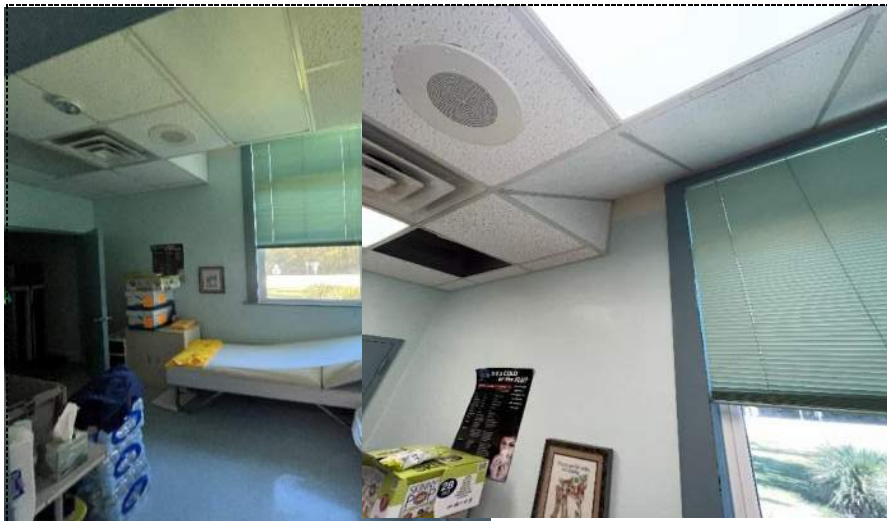
Photo 13 -
Evidence of roof
leaks, wall damage
and possible
microbial
amplification
above ceiling in
first office on
South side of
building 1.

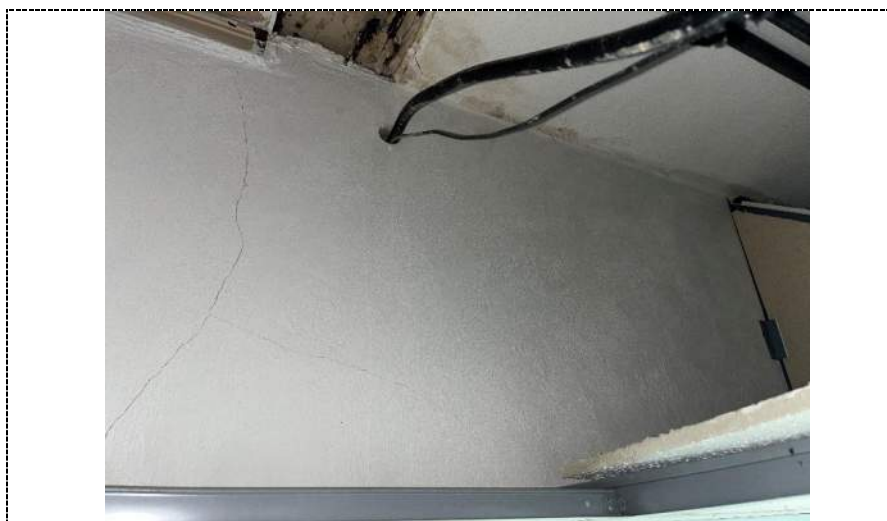
Photo 14 -
Wall damage and
possible microbial
amplification
above ceiling in
first office on
South side of
building 1.

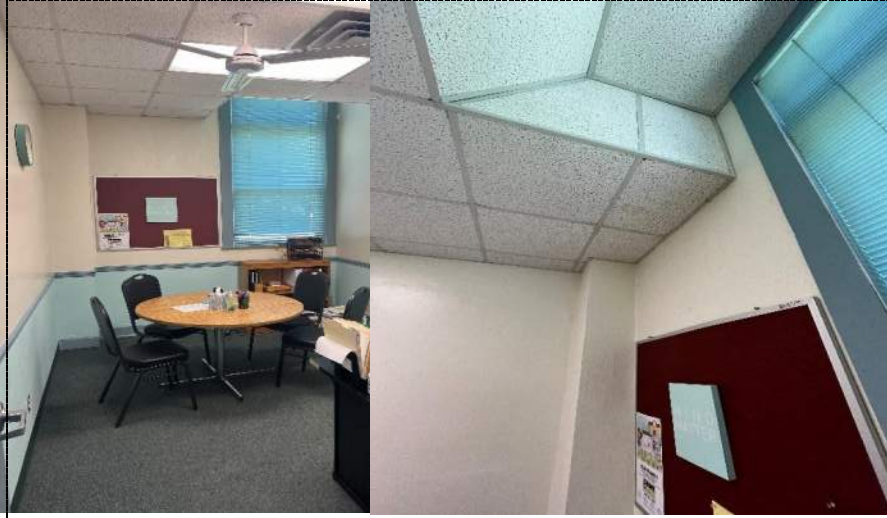
Photo 15 - Evidence of above ceiling leak in center office in hallway leading to break room in building 1.

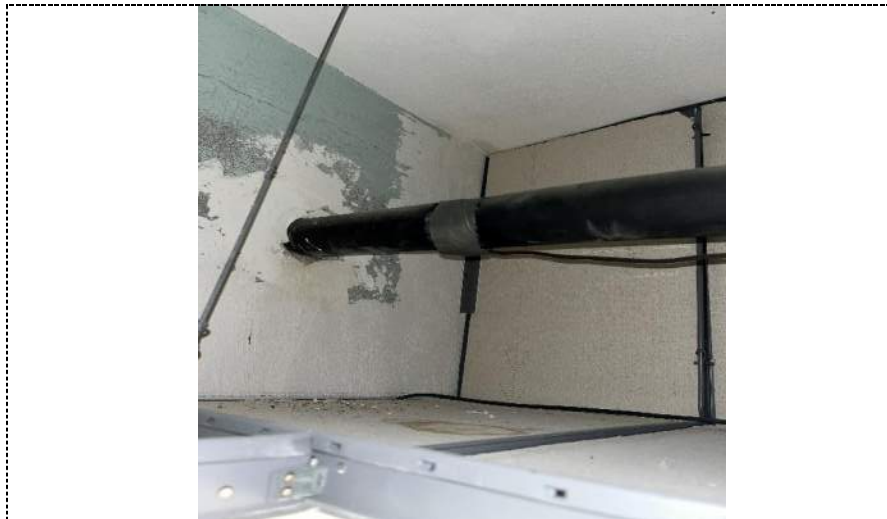
Photo 16 - Source of above ceiling leak in center office in hallway leading to break room in building 1..

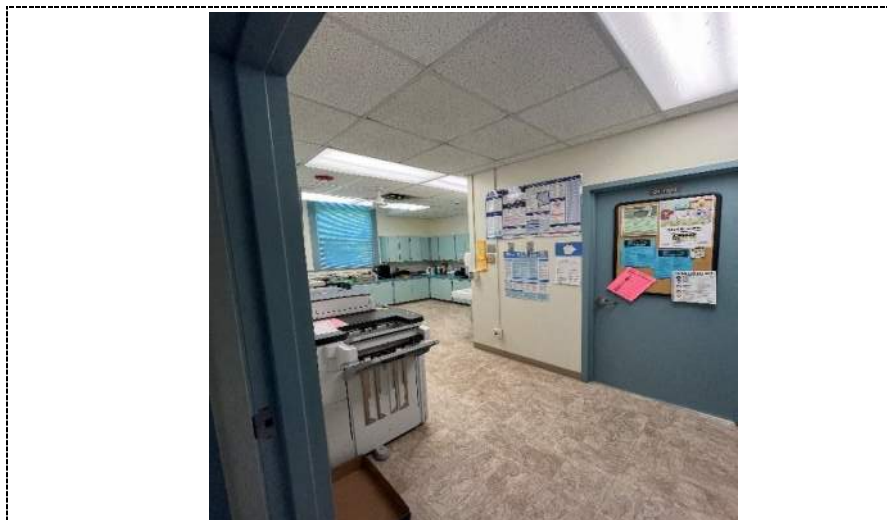
Photo 17 - Break room building 1.

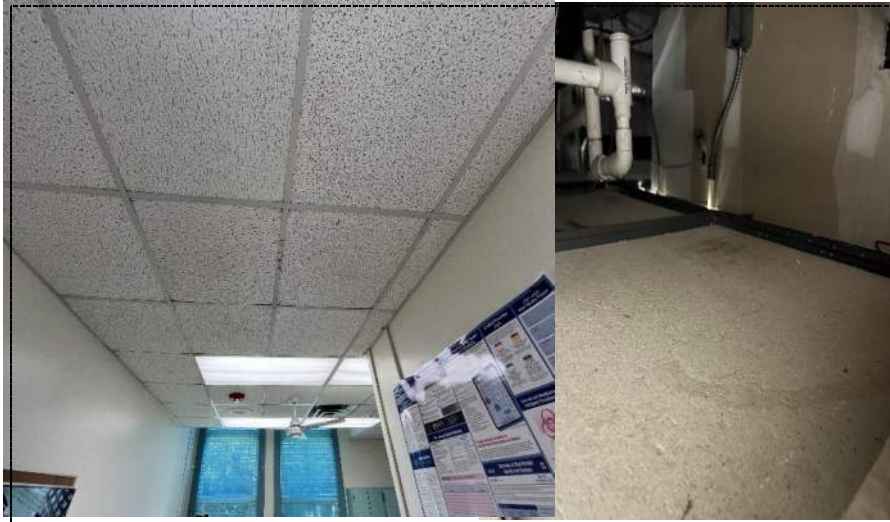
Photo 18 -
Slight water
staining on ceiling
tile below air
handler in break
room -building 1.

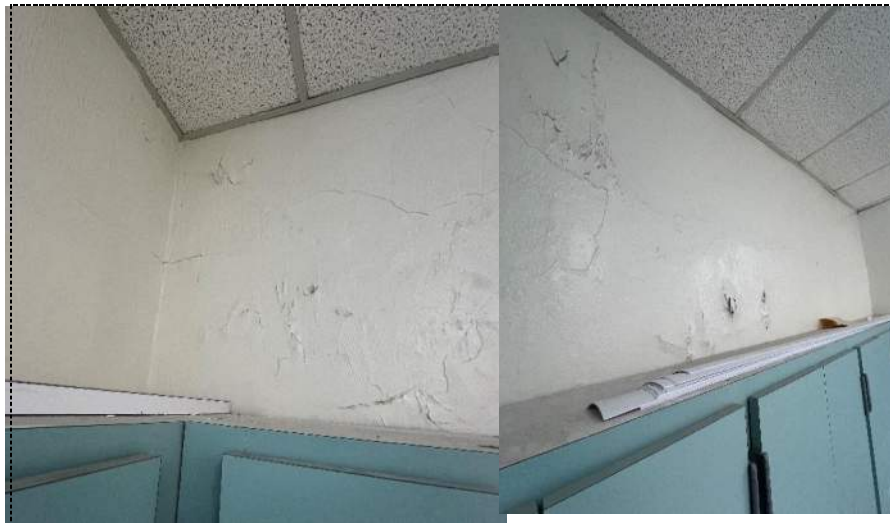
Photo 19 -
Wall damage in
Southeast corner
of break room
corresponding to
Southeast exterior
infill-building 1.

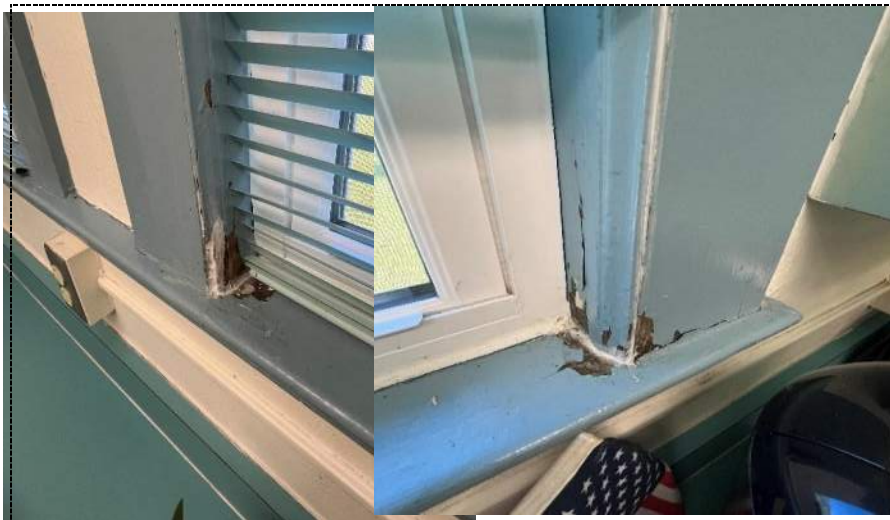
Photo 20 -
Evidence of water
intrusion and wall
damage along
exterior wall on
admin side of
building 1.

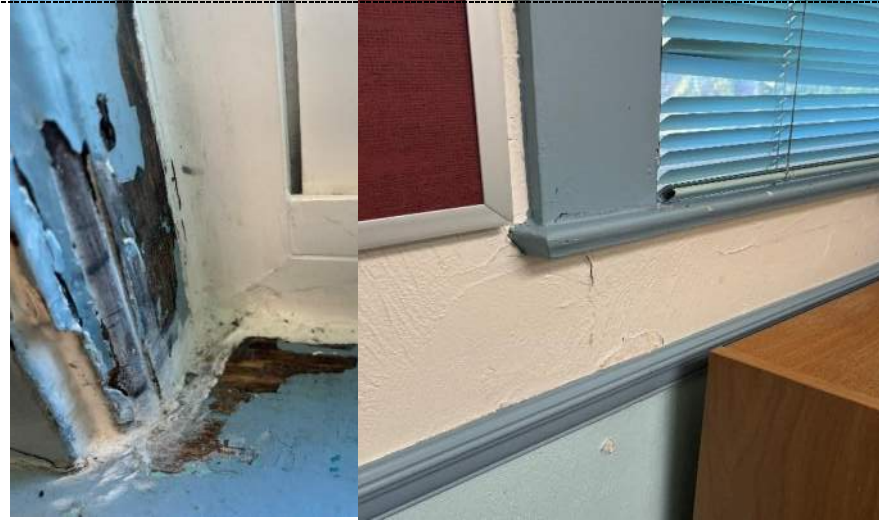
Photo 21 -
Evidence of water intrusion and wall damage along exterior wall on admin side of building 1.

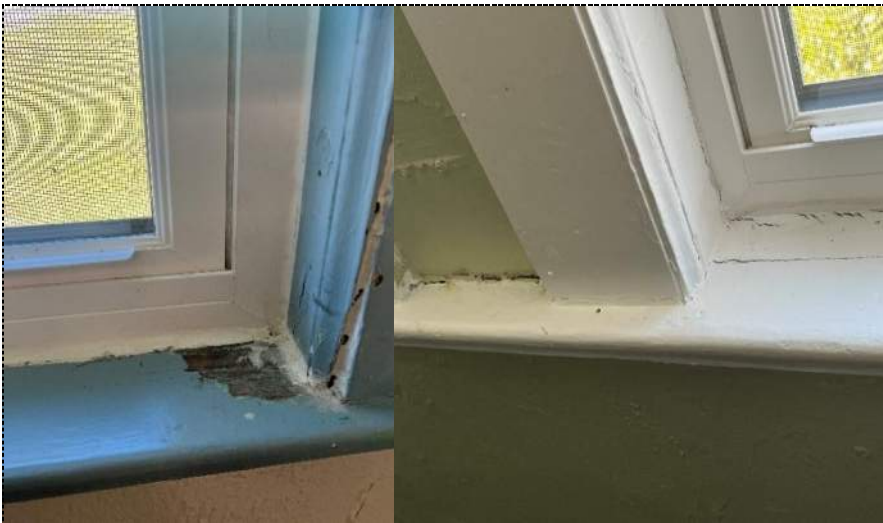
Photo 22 -
Evidence of water intrusion and wall damage along exterior wall on admin side of building 1.

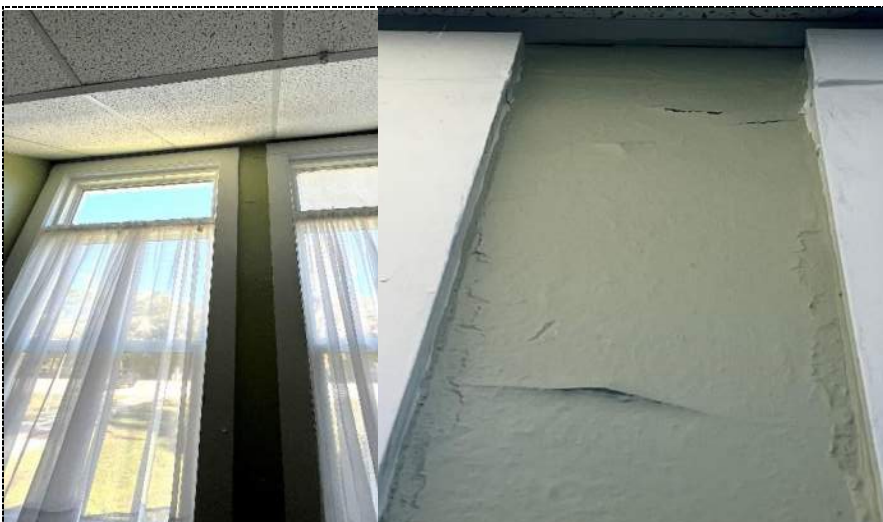
Photo 23 -
Evidence of water intrusion and wall damage along exterior wall on admin side of building 1.

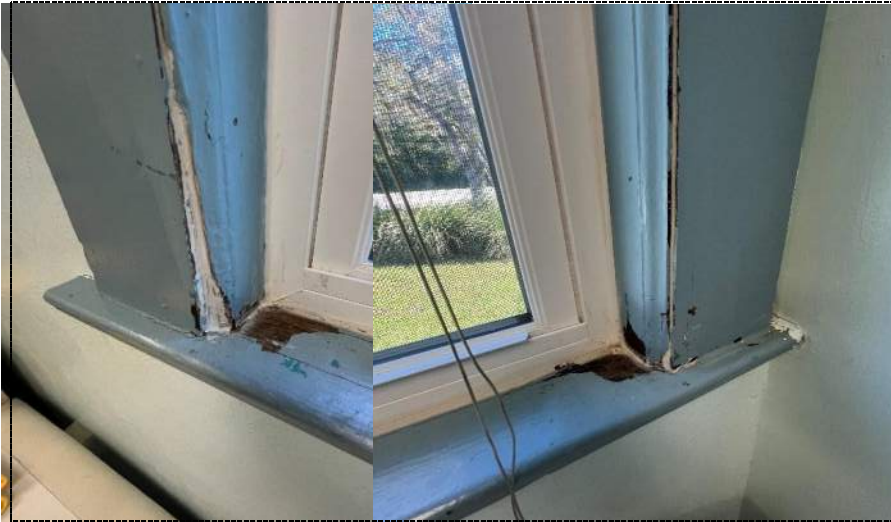
Photo 24 - Evidence of water intrusion and wall damage along exterior wall on admin side of building 1.

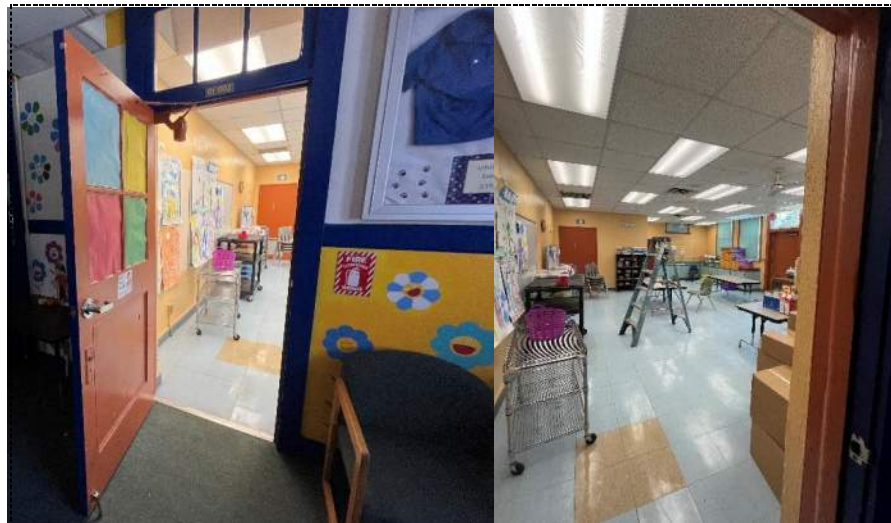
Photo 25 - Entry to front building 1 front Northeast conference room (as noted on map).

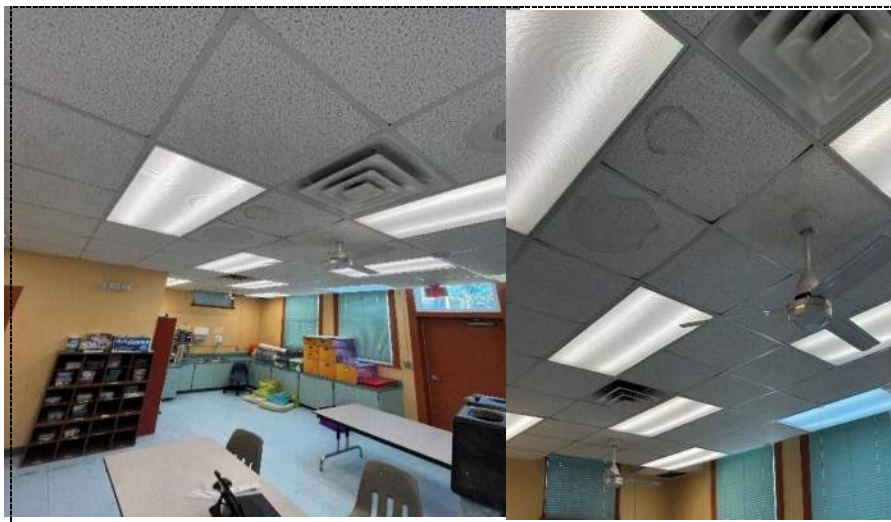
Photo 26 - Water stained ceiling tiles in the conference room-building 1.

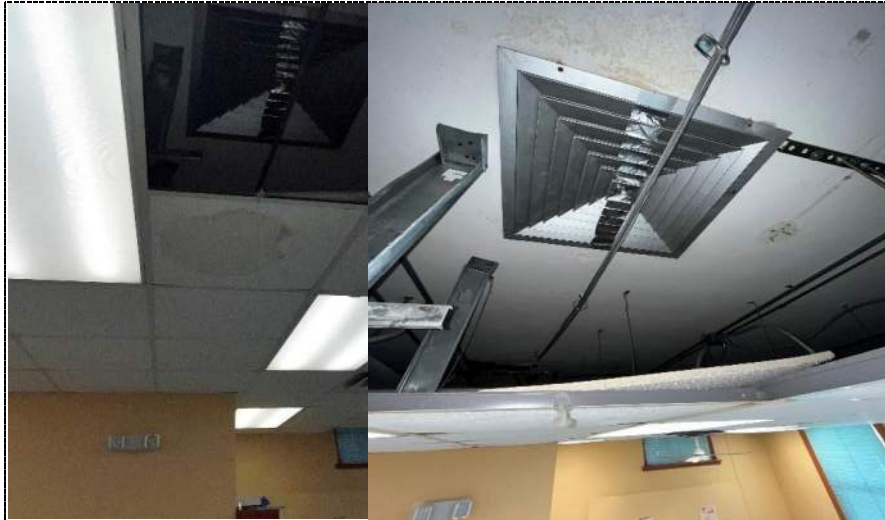
Photo 27 - Possible active and sweating diffuser above the drop ceiling in conference room-building 1.

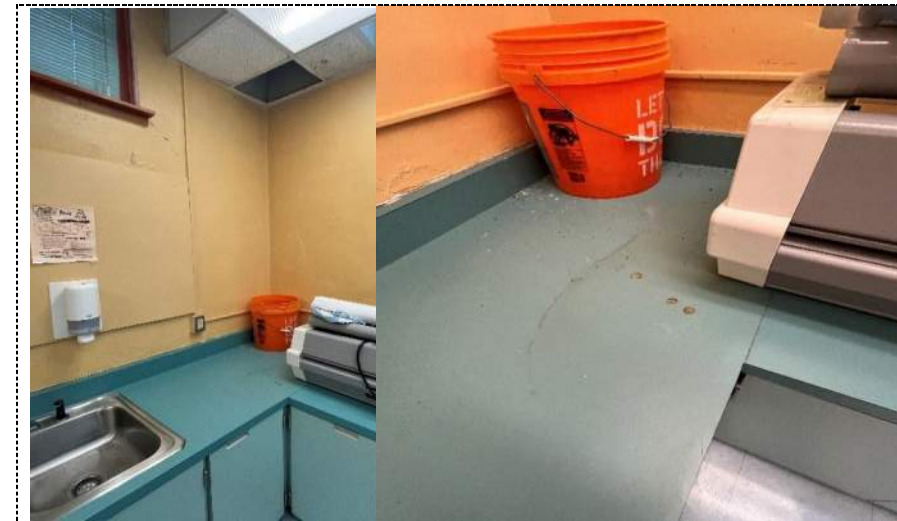
Photo 31 - Collapsed ceiling tile with catch bucket and water staining on countertop in conference room - building 1.

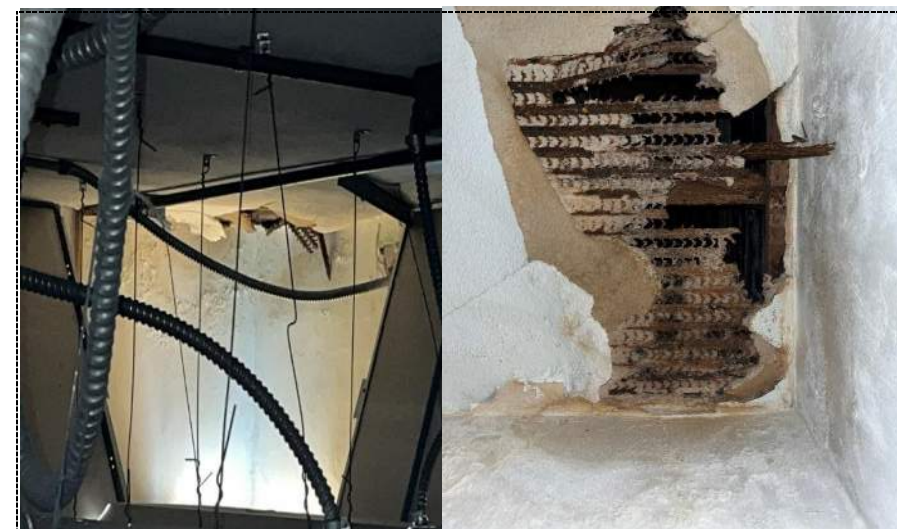
Photo 32 - Collapsed ceiling above drop ceiling with evidence of roof leak in conference room - building 1.

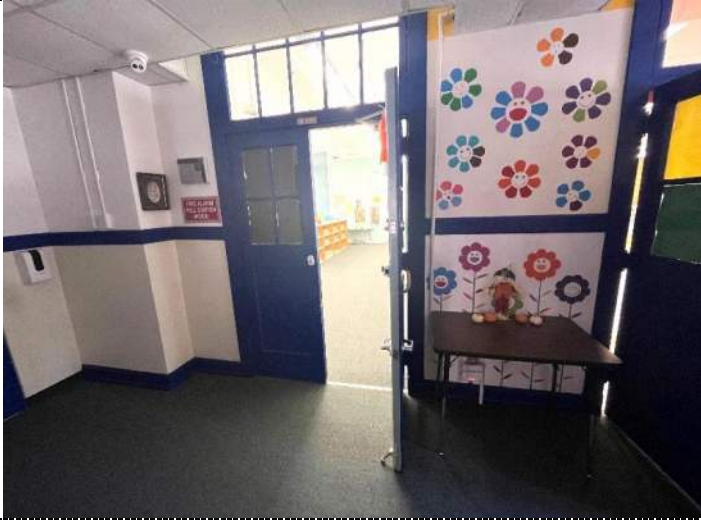
Photo 33 -
Entrance to Media
room-building 1.

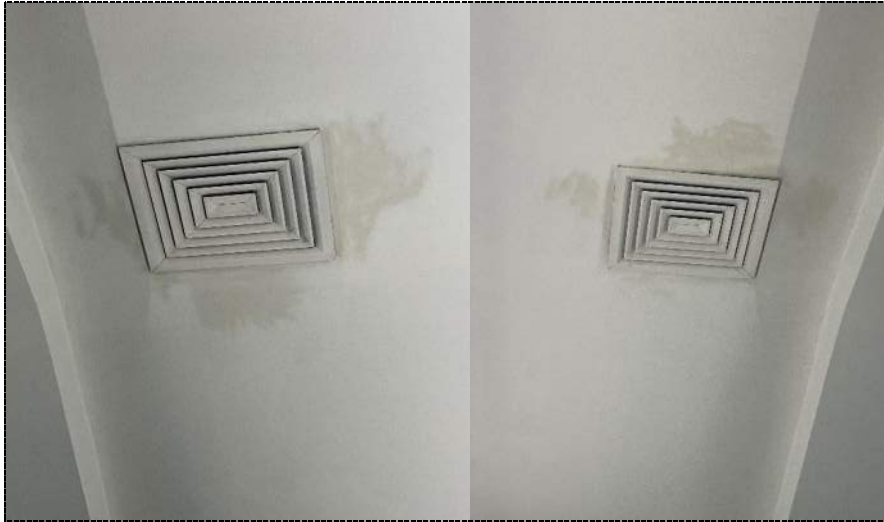
Photo 36 -
Water staining
around diffusers in
Media room-
building 1.

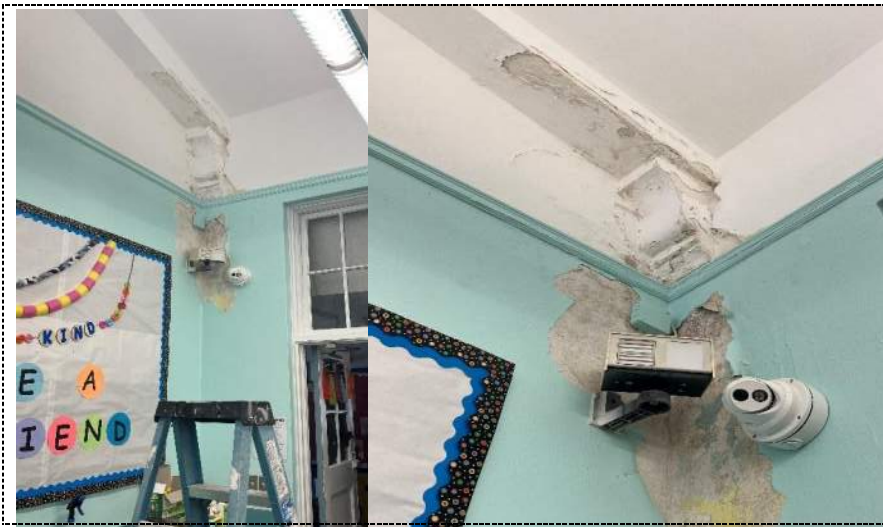
Photo 37 -
Water damaged
walls with
microbial
amplification in
Media room-
building 1.

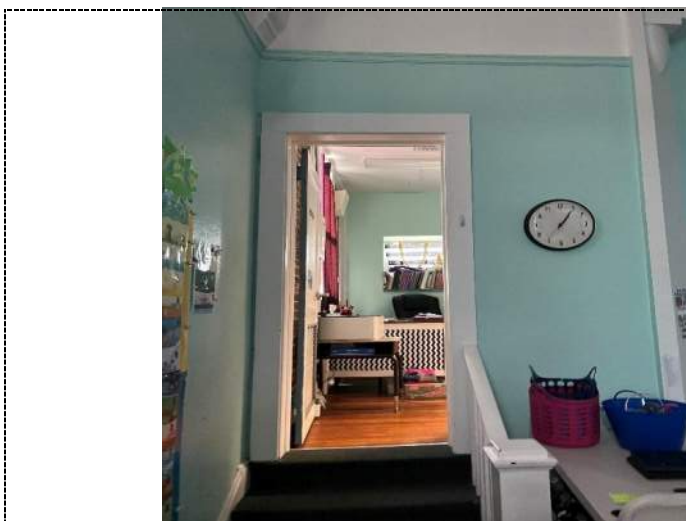
Photo 38 -
Entry to office
behind Media
room-building 1.

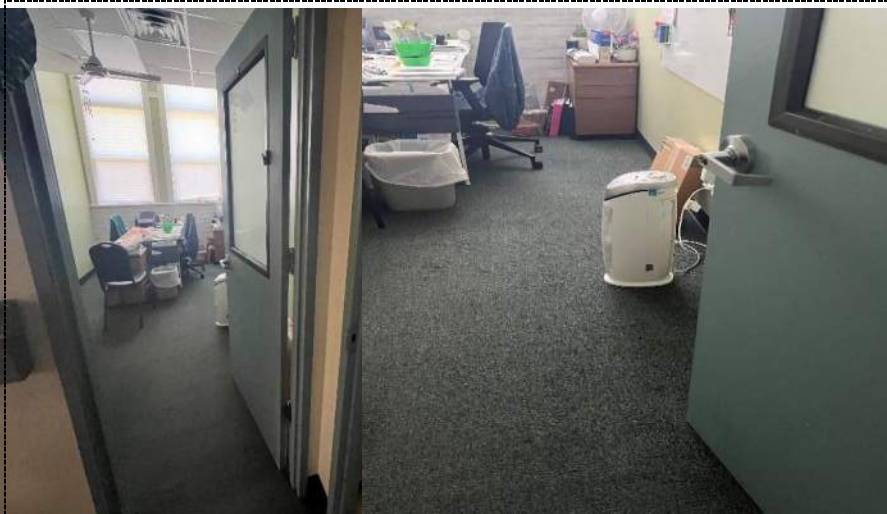
Photo 44 -
Various tower fans
observed
throughout building
1.

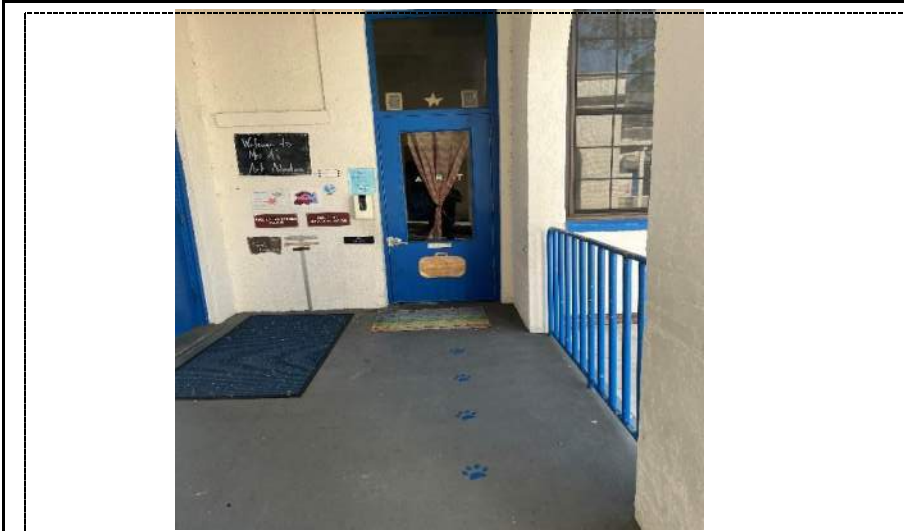
Photo 45 -
Entrance to Art
room-building 1.

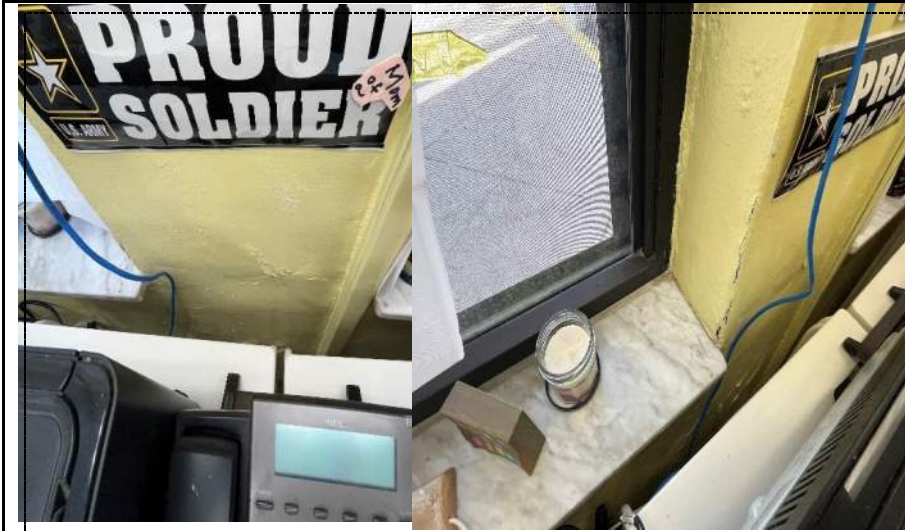
Photo 48 -
Evidence of wall
damage of Art
room-building 1.

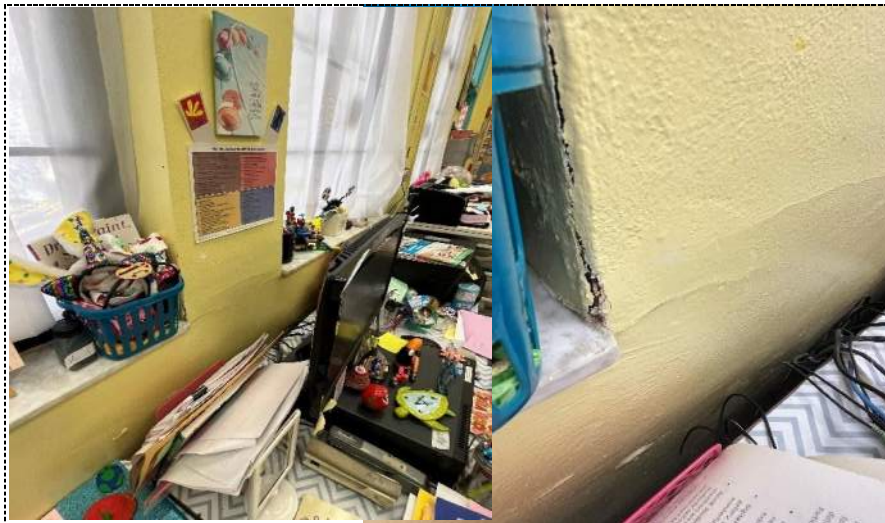
Photo 49 -
Evidence of wall
damage of Art
room-building 1.

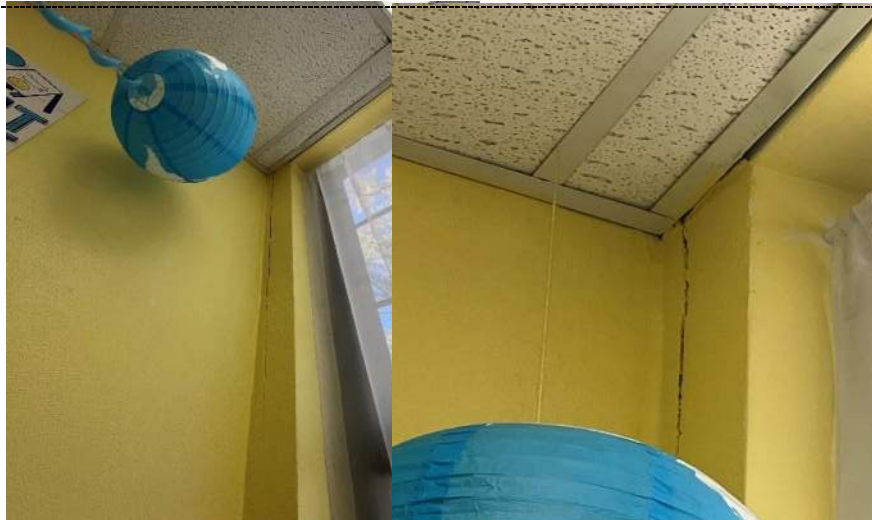
Photo 50 -
Structural crack in
Northwest corner
of Art room-
building 1.

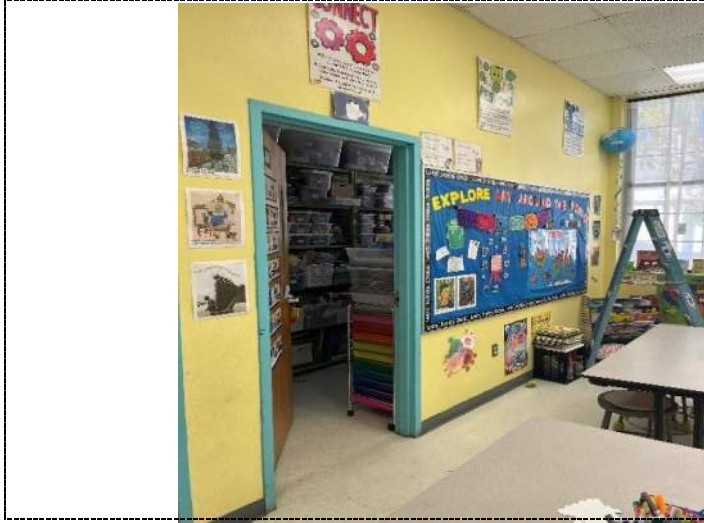
Photo 51 - Entrance to Art room closet-building 1.

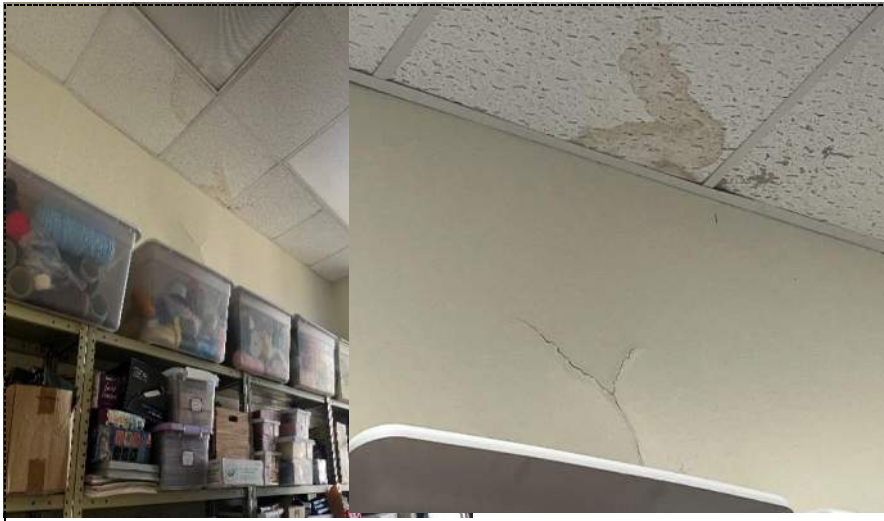
Photo 52 - Water stained ceiling tiles and wall damage in Art room closet-building 1.

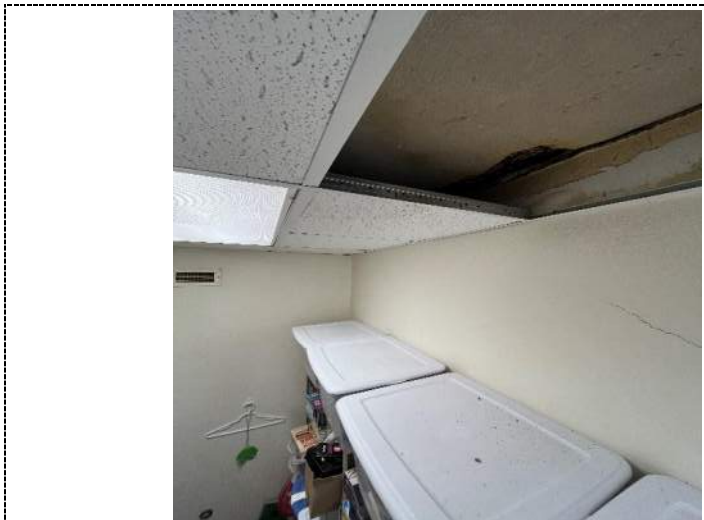
Photo 53 - Evidence of roof leak above ceiling in Art room closet-building 1.

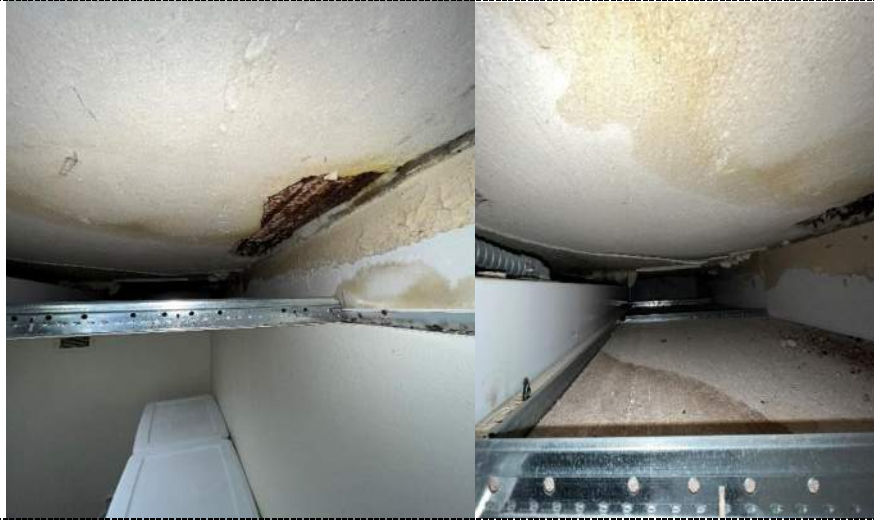
Photo 54 -
Evidence of roof
leak above ceiling
in Art room closet-
building 1.

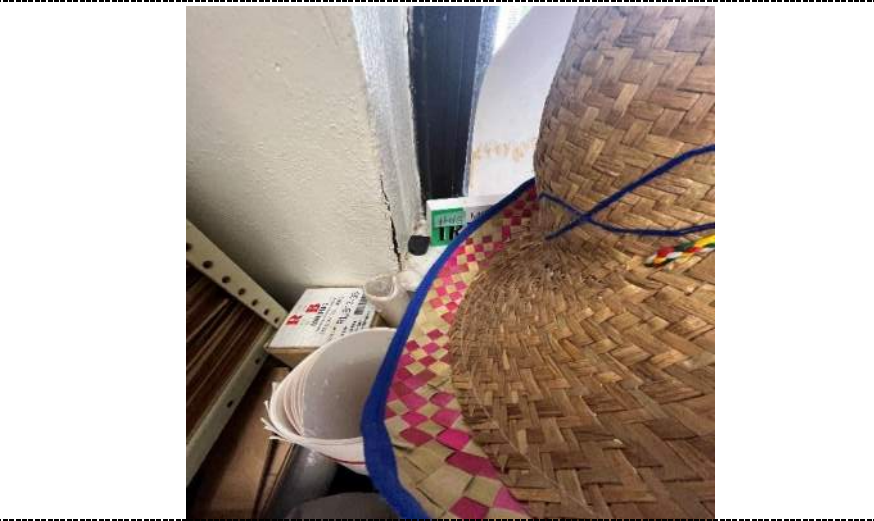
Photo 55 -
Evidence of
damage around
window in Art room
closet-building 1.

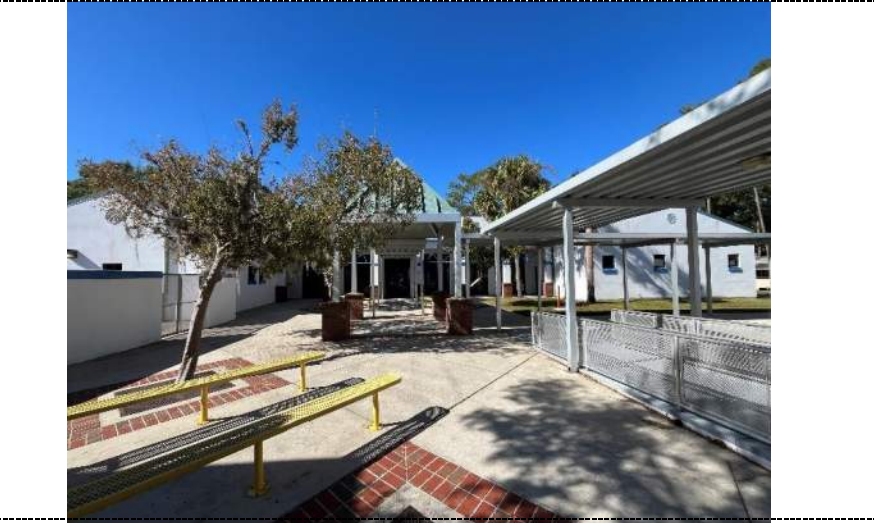
Photo 56 -
Entrance to
building 3.

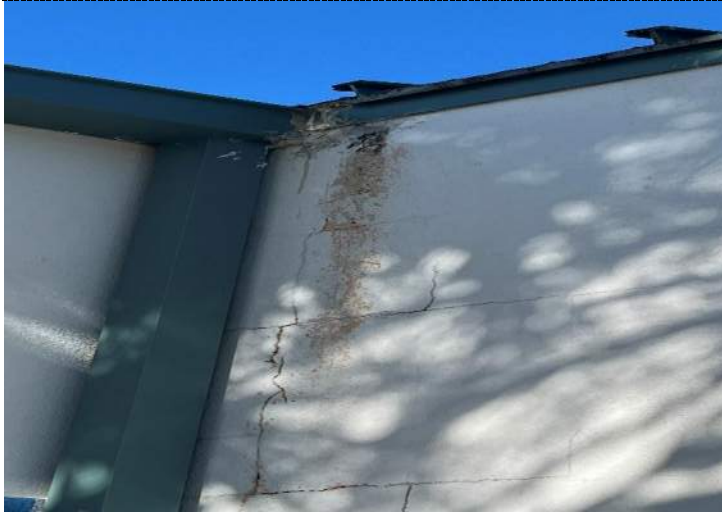
Photo 57 - Exterior cracking and area of questionable roofing to North of entrance into building 3.

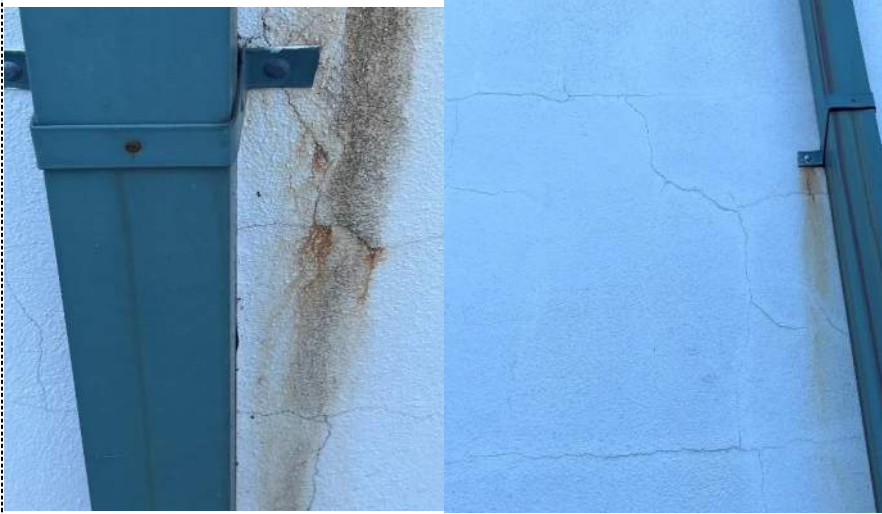
Photo 58 - Wall damage next to downspouts-building 3.

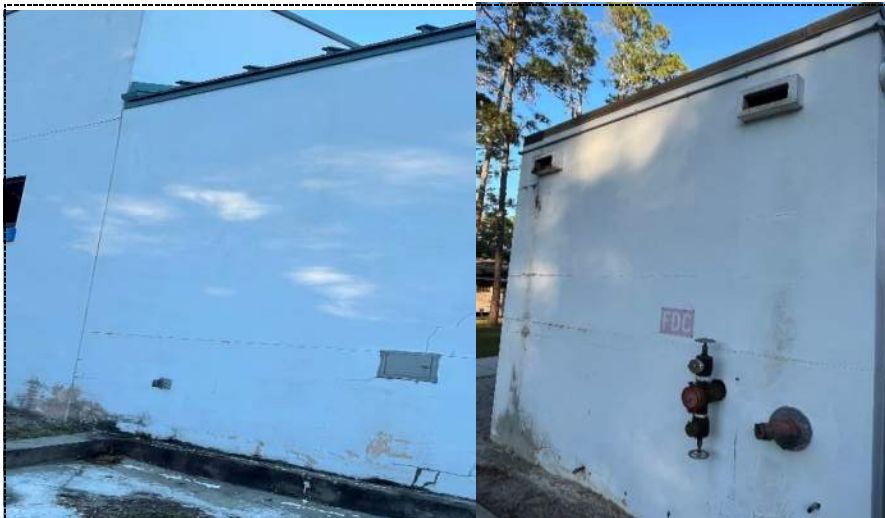
Photo 59 - Exterior cracking and areas of failing weatherproofing around building-building 3.

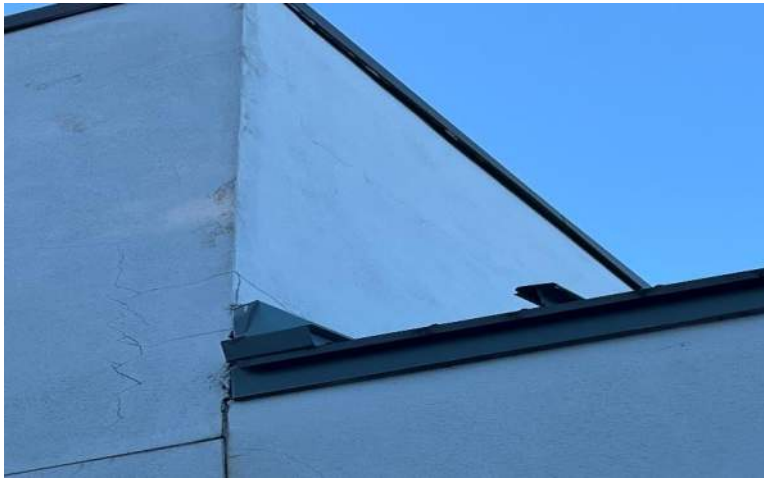
Photo 60 - Possible structural corner crack-building 3.

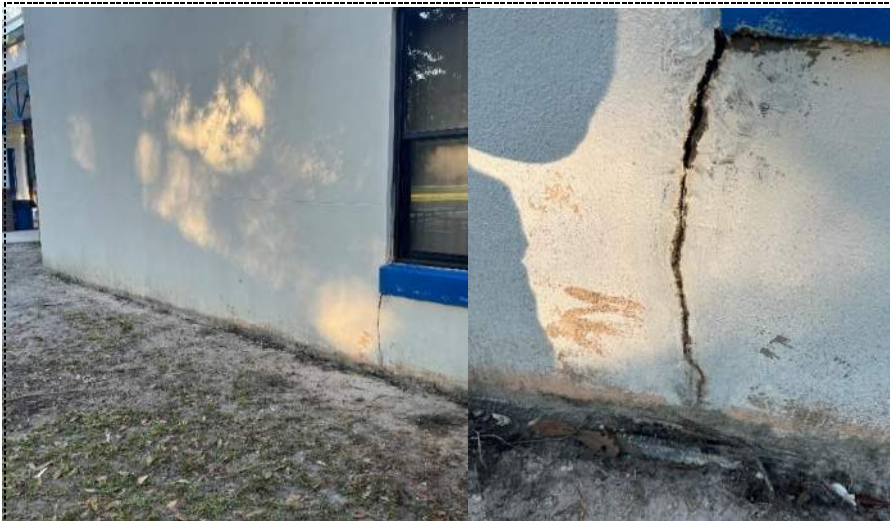
Photo 61 - Exterior structural crack with interior damage in Southwest corner of Cafeteria-building 3.

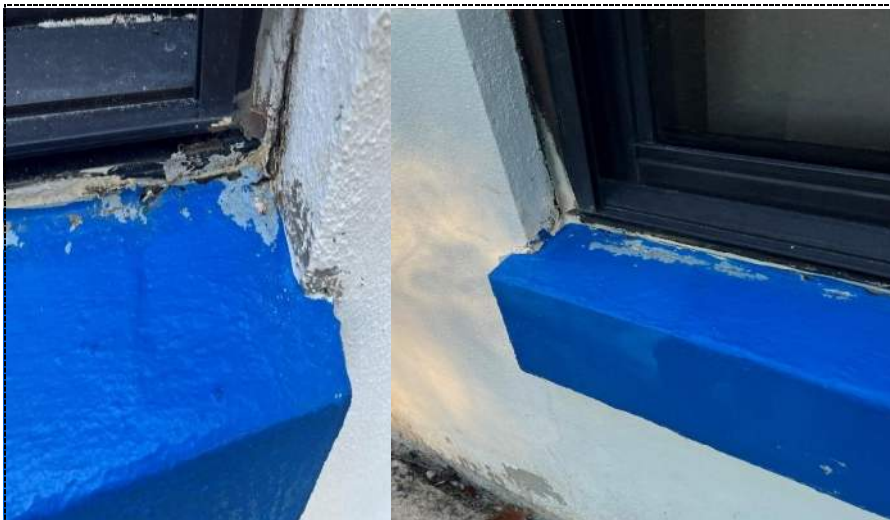
Photo 62 - Evidence of window seal deficiencies-building 3.

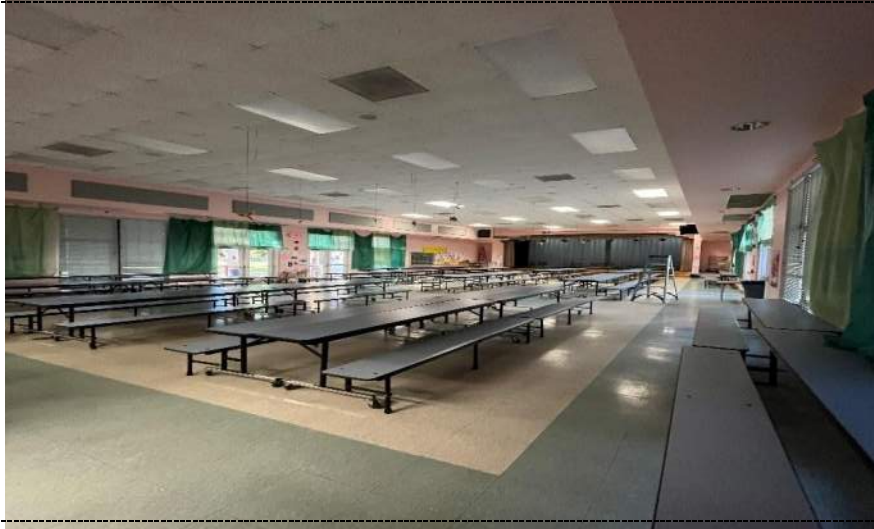
Photo 63 -
Cafeteria-building
3.

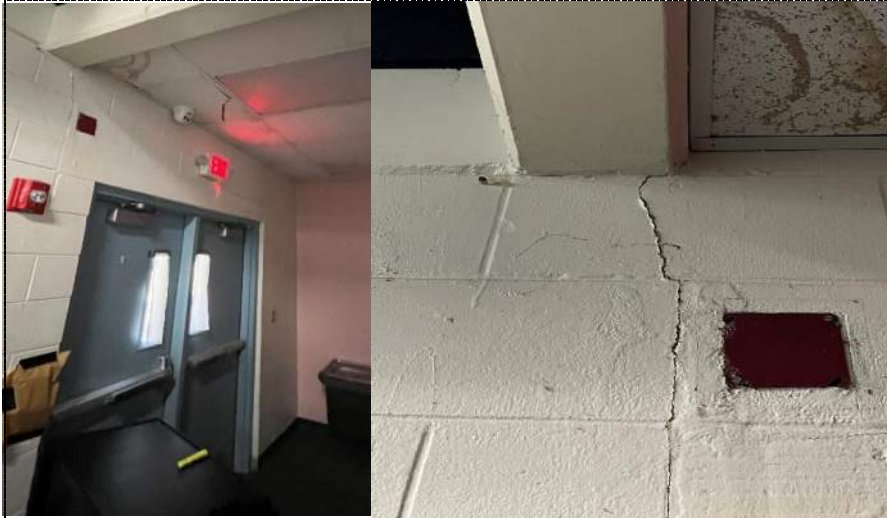
Photo 66 - Water staining ceiling tiles and cross block cracking at end of hallway along Northeast side of Cafeteria-building 3.

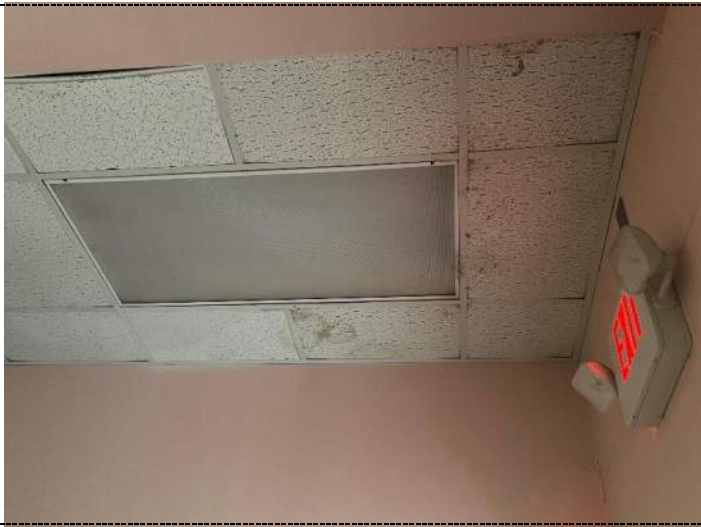
Photo 67 - Water stained ceiling tiles in hallway along Northeast side of Cafeteria-building 3.
