LIMITED INDOOR AIR QUALITY (IAQ) and MICROBIAL ASSESSMENT REPORT

Project Location:

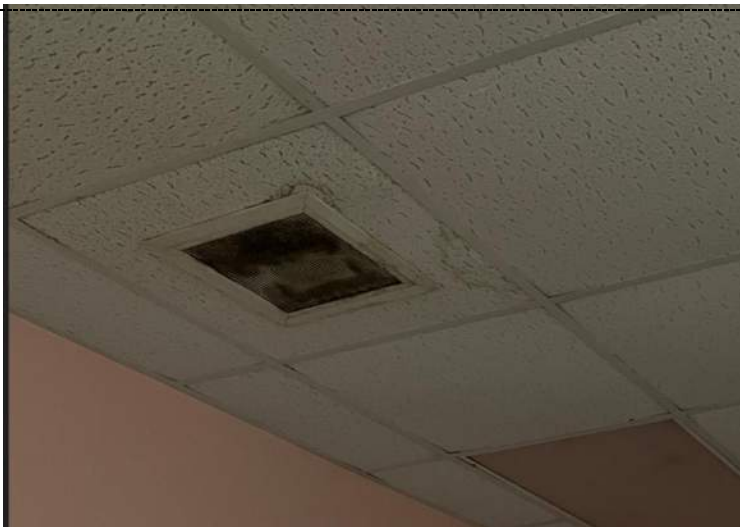
Photo 68 - Casting and possible microbial amplification and evidence of moisture around diffuser in hallway along Northeast side of Cafeteria-building 3.

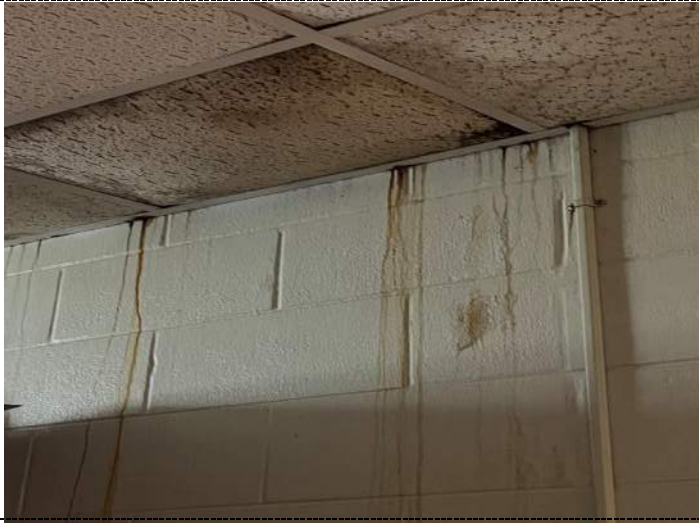
Photo 69 - Water infiltration and impacted ceiling tiles that corresponds to a structural exterior crack and possible roof compromise in first room in hallway along Northeast side of Cafeteria-building 3.

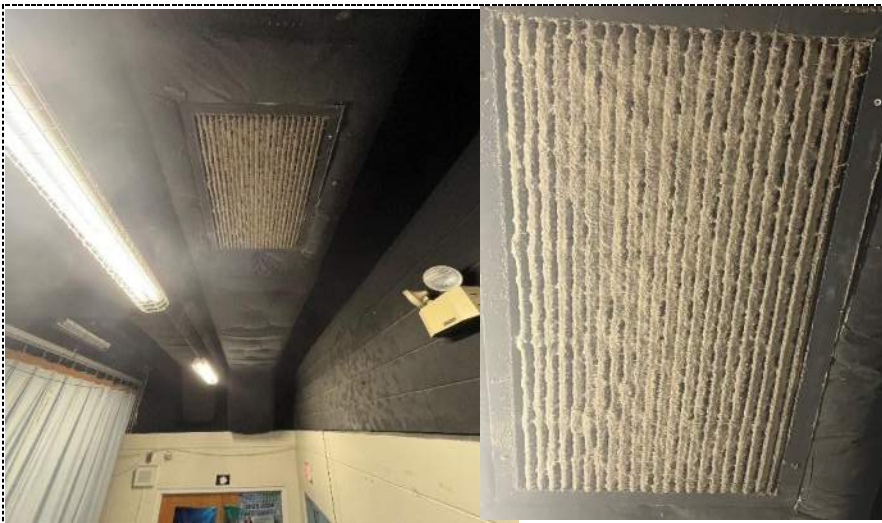
Photo 70 - Very dirty HVAC grate and possible microbial amplification on North wall behind stage outside of PE office-building 3.

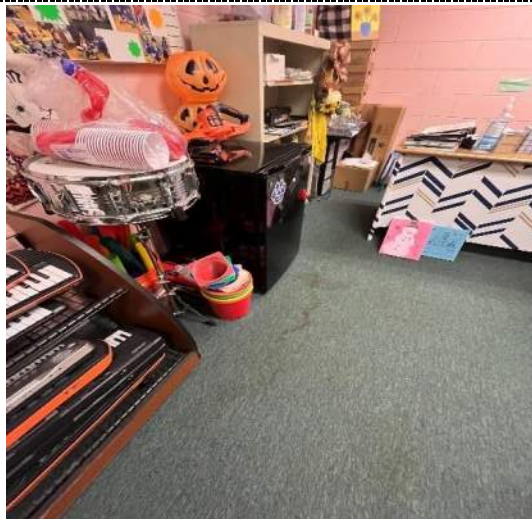
Photo 73 -
Water staining on
carpet in front of
dorm refrigerator
in PE office-
building 3.

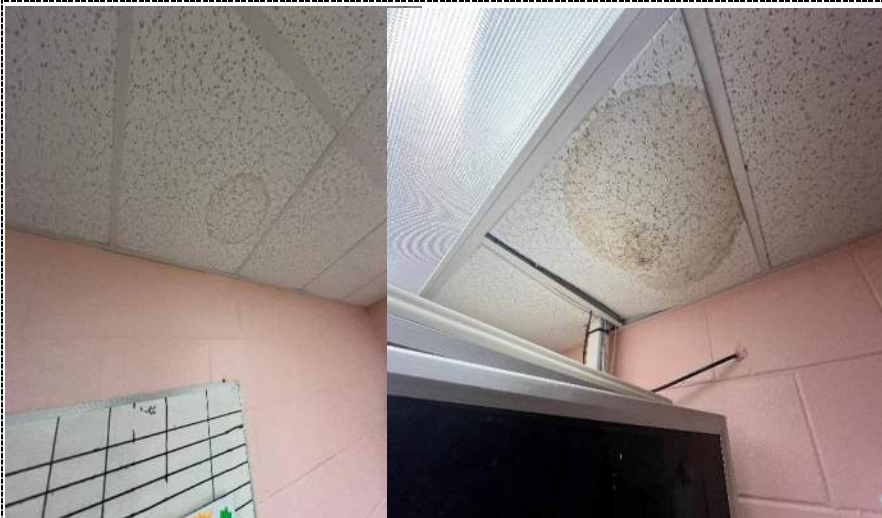
Photo 74 -
Water staining on
ceiling tiles in PE
office-building 3.

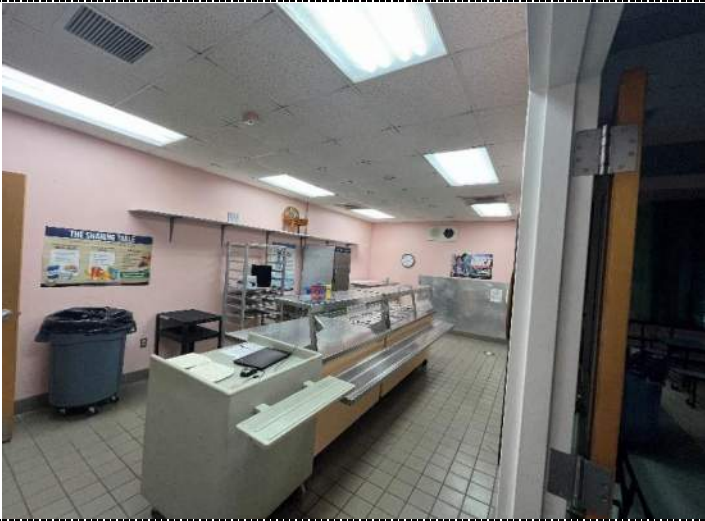
<p>Photo 76 - Kichen-building 3.</p>

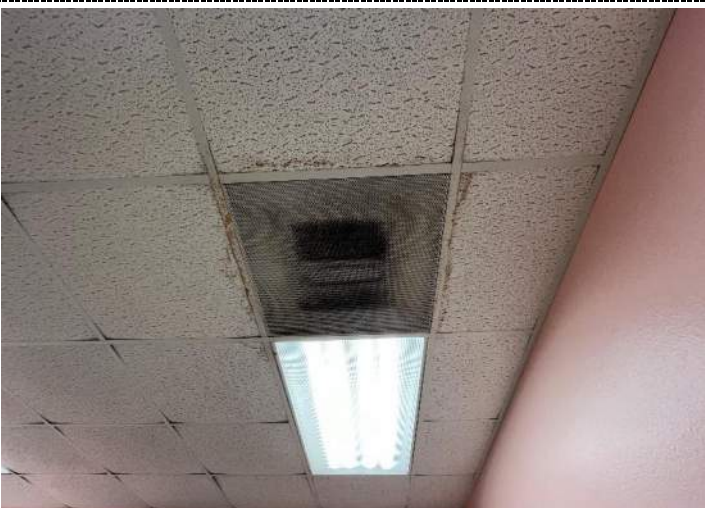
<p>Photo 77 - Casting around kitchen diffusers and rusted ceiling grid-building 3.</p>

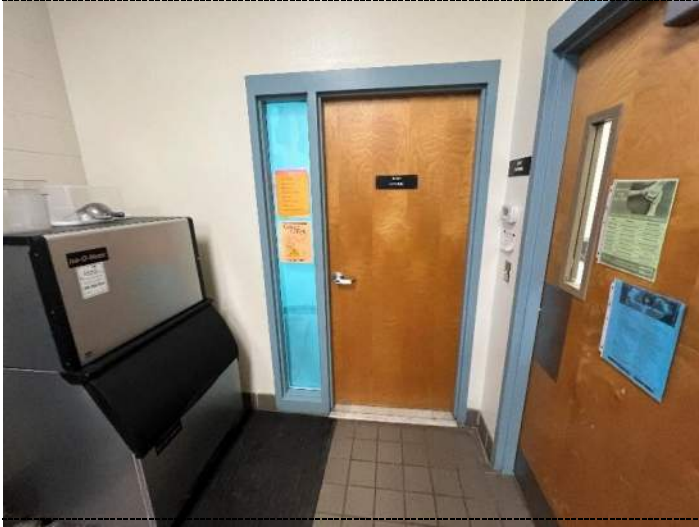
Photo 78 -
Entrance to
kitchen managers
office-building 3.

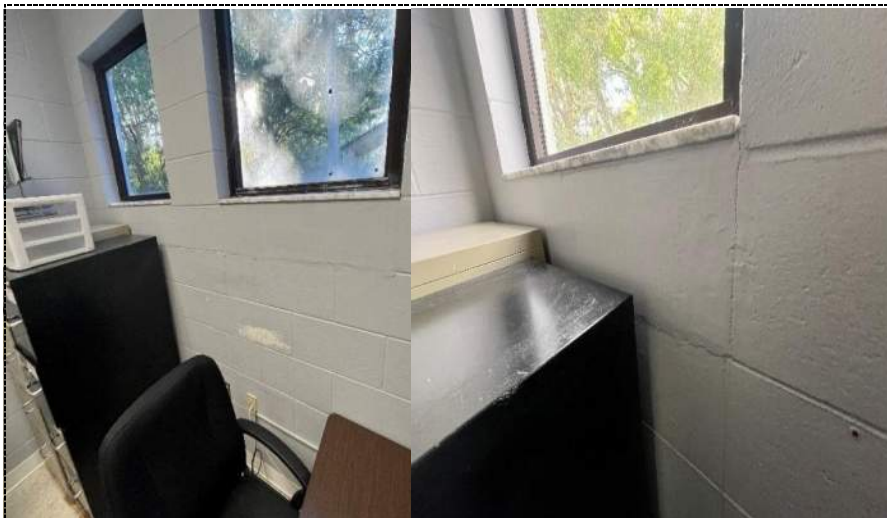
Photo 80 -
Evidence of
repairs/infills in
kitchen managers
office-building 3.

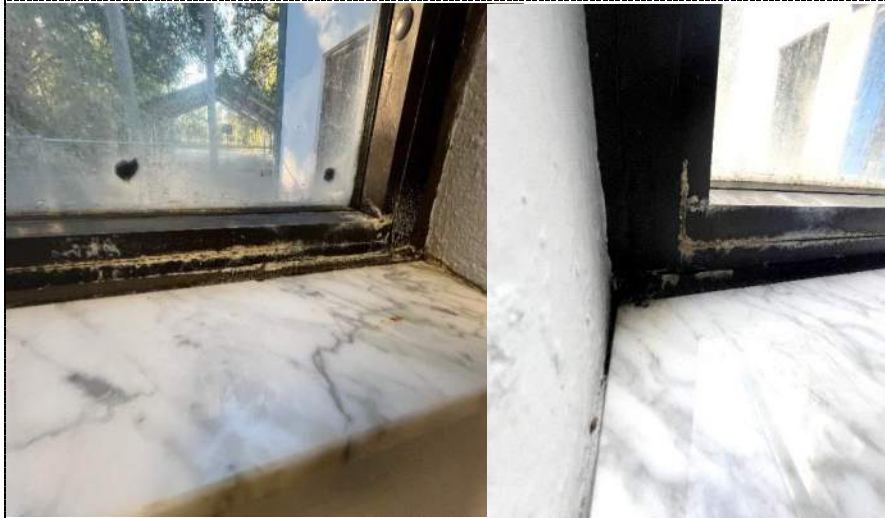
Photo 81 - Evidence of window leaks in kitchen managers office-building 3.

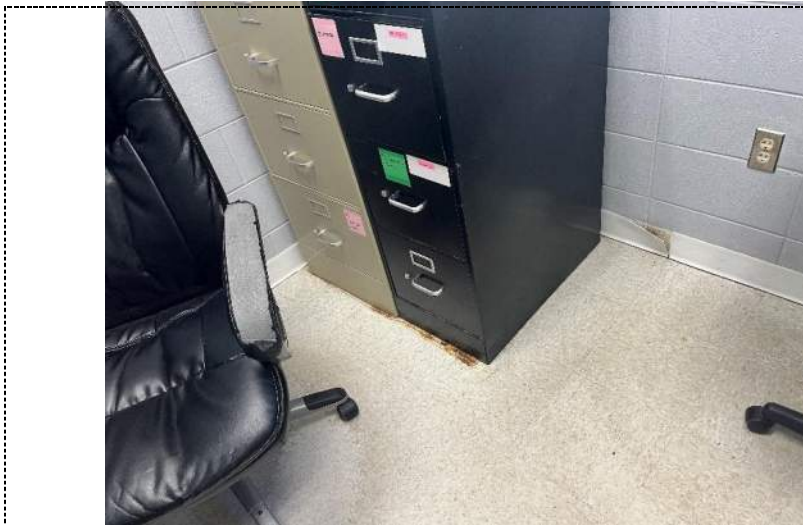
Photo 82 - Rust under cabinets and peeling cove base in the kitchen managers office-building 3.

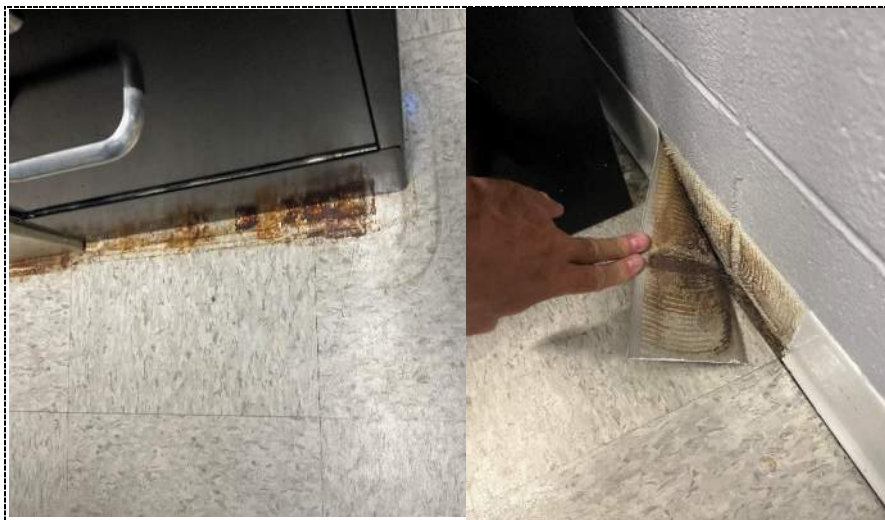
Photo 83 - cabinets and peeling cove base in the kitchen managers office-building 3.

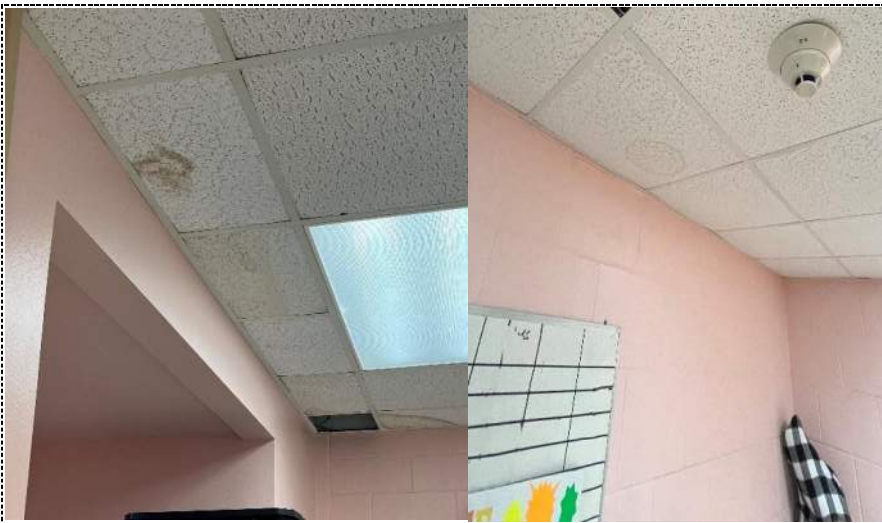
Photo 85 - Water stained ceiling tiles in room to the Southwest corner of Cafeteria-building 3.

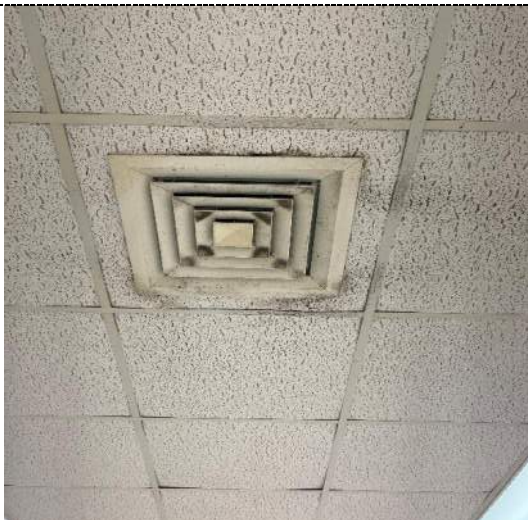
Photo 86 - Casting around diffuser with possible microbial amplification room to the Southwest corner of Cafeteria-building 3.

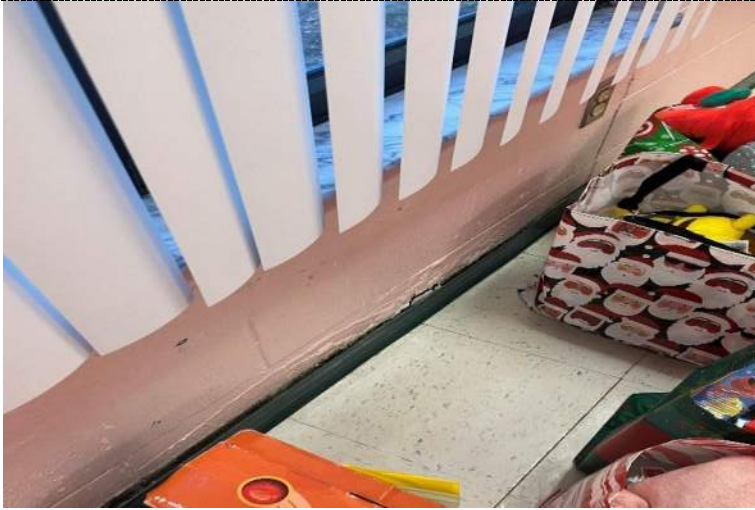
Photo 87 -
Water damage
along West wall in
room to the
Southwest corner
of Cafeteria-
building 3.

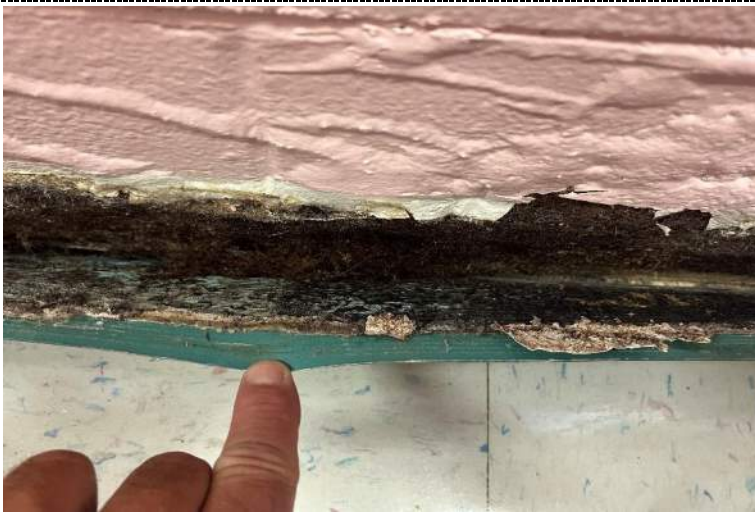
Photo 88 -
Peeling cove base
with possible
microbial
amolification
underneath in
room to the
Southwest corner
of Cafeteria-
building 3.

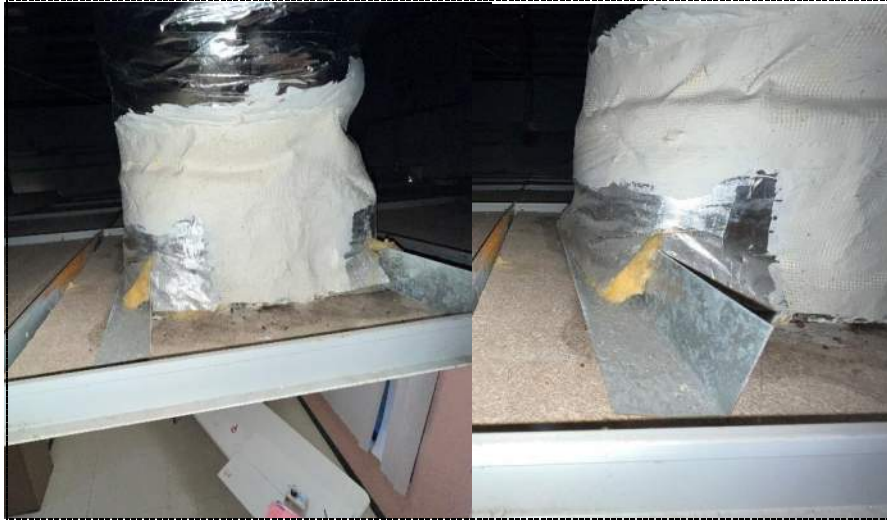
Photo 90 - Poorly sealed diffuser with evidence of moisture impact on the back of surrounding ceiling tiles in room to the Southwest corner of Cafeteria-building 3.

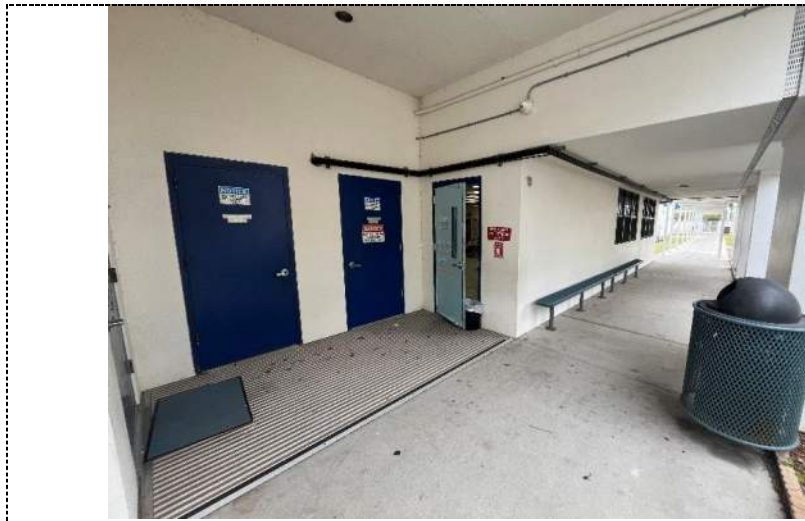
Photo 91 - Typical entrance to classrooms (South pod Southwest entrance pictured)-building 2.

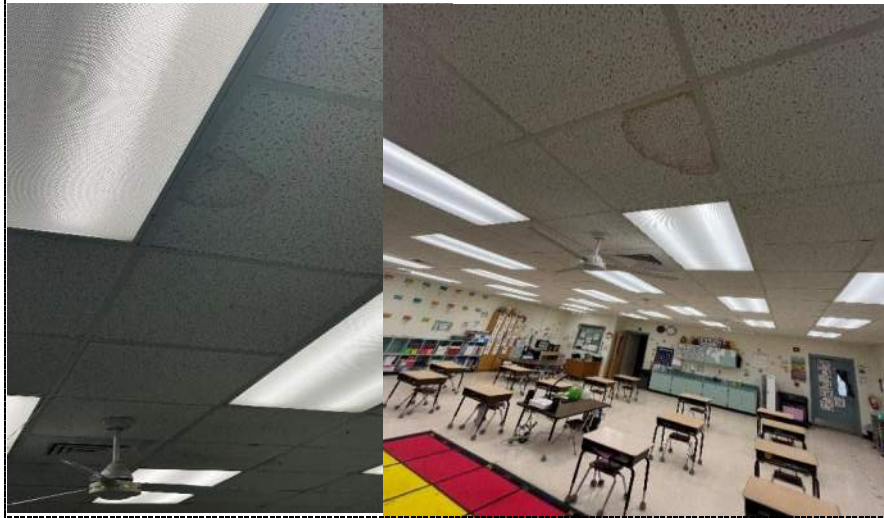
Photo 93 -
Water stained
ceiling tiles
throughout North
and South
classrooms-
building 2.

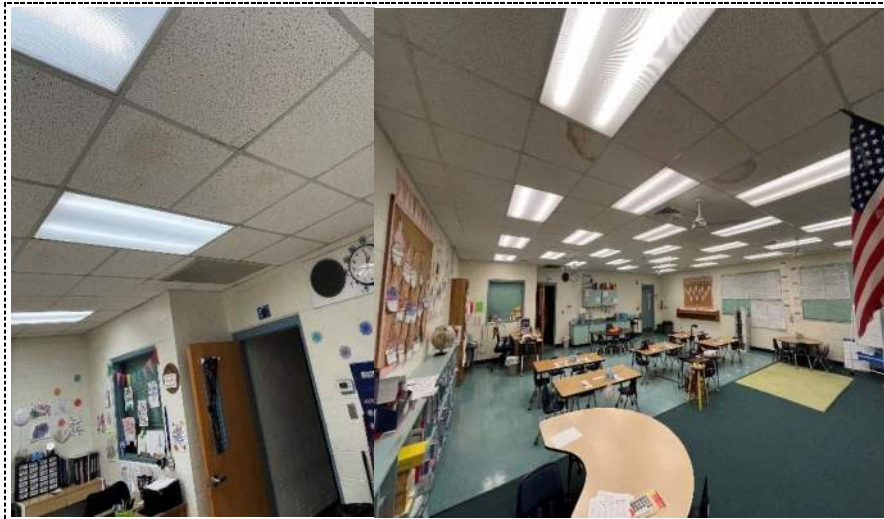
Photo 94 -
Water stained
ceiling tiles
throughout North
and South
classrooms-
building 2.

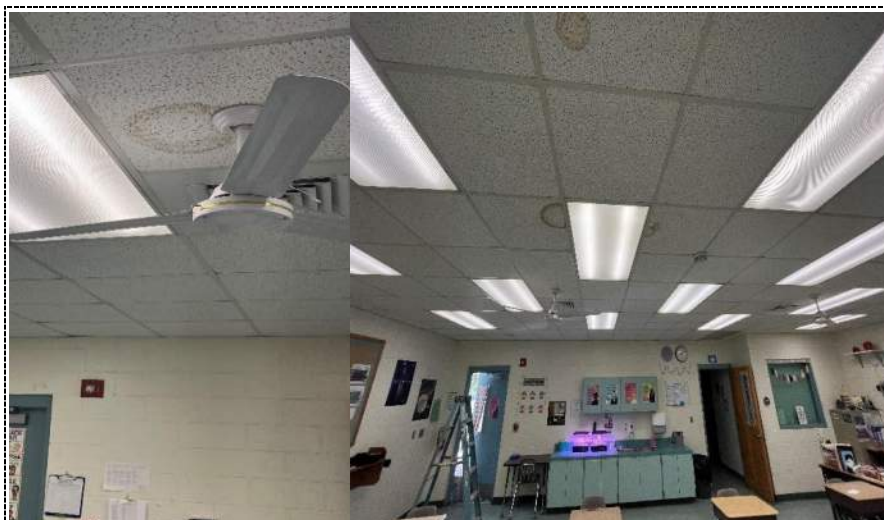
Photo 95 -
Water stained
ceiling tiles
throughout North
and South
classrooms-
building 2.

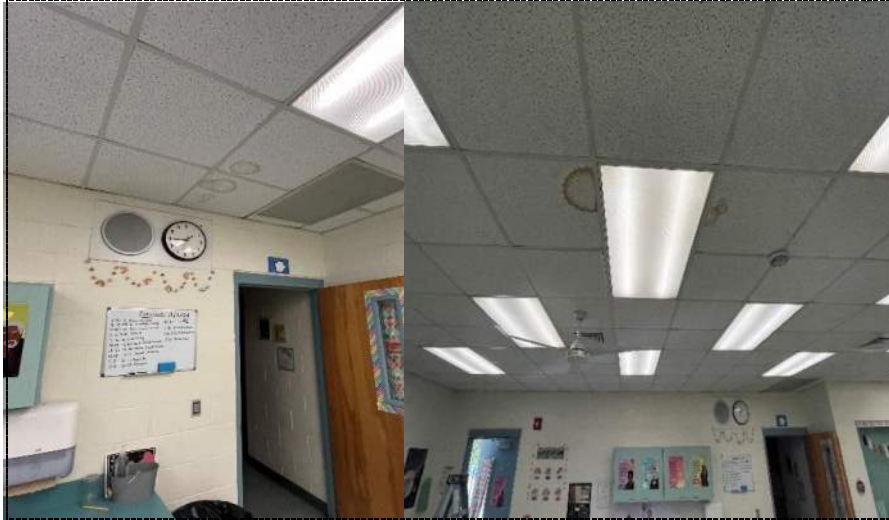
Photo 96 - Water stained ceiling tiles throughout North and South classrooms-building 2.

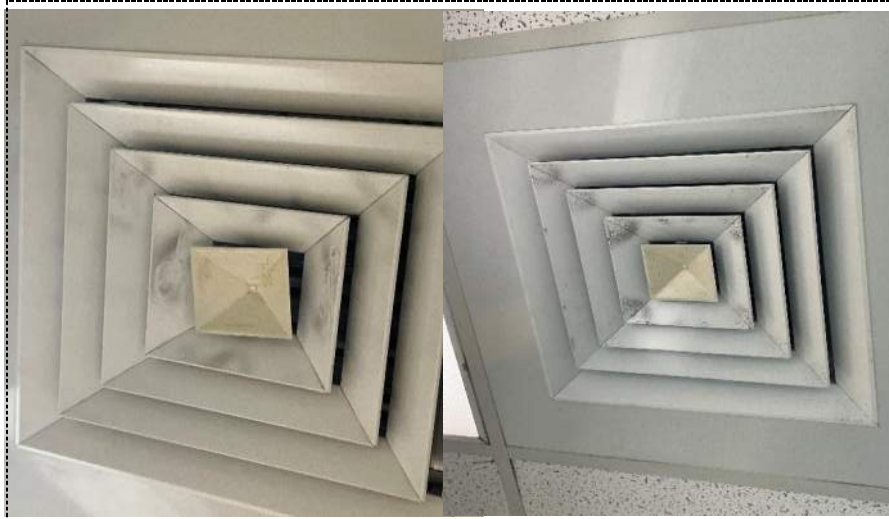
Photo 97 - Impacted diffusers throughout North and South classrooms-building 2.

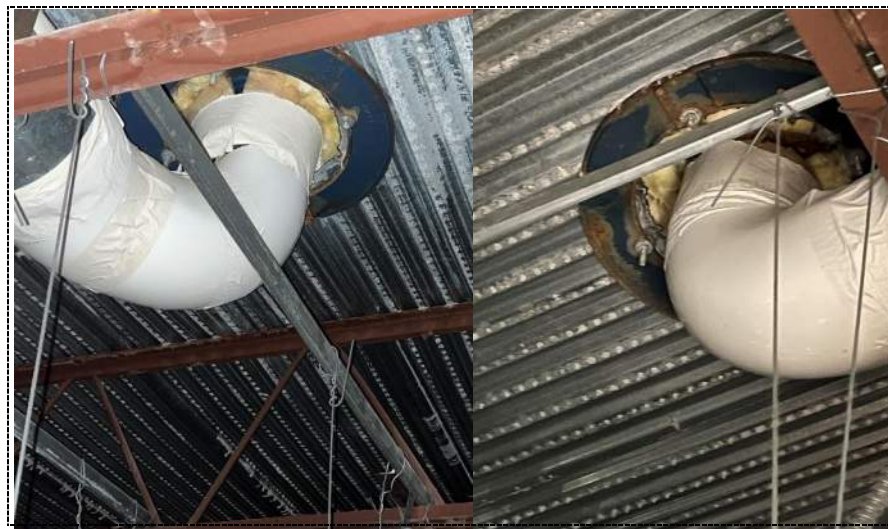
Photo 101 - Evidence of above ceiling leaking rain leaders in classrooms-building 2.

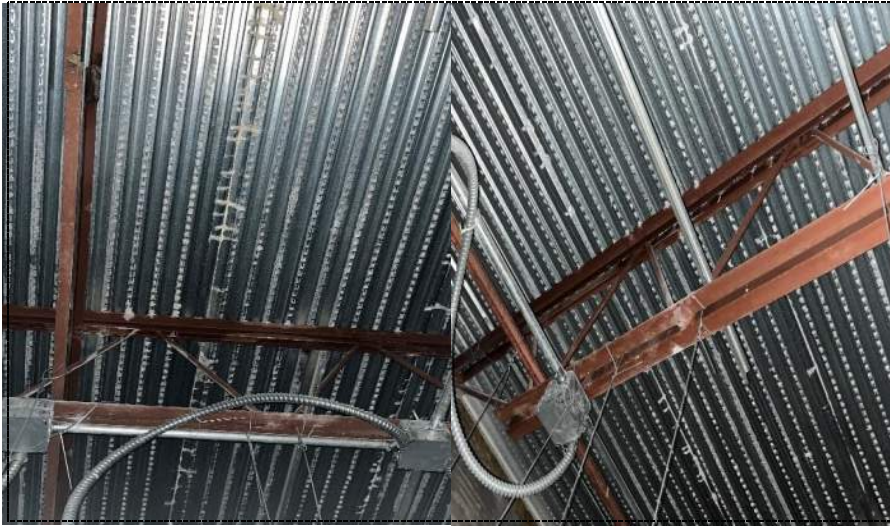
Photo 102 - Evidence of roof leaks above ceilings in classrooms-building 2.

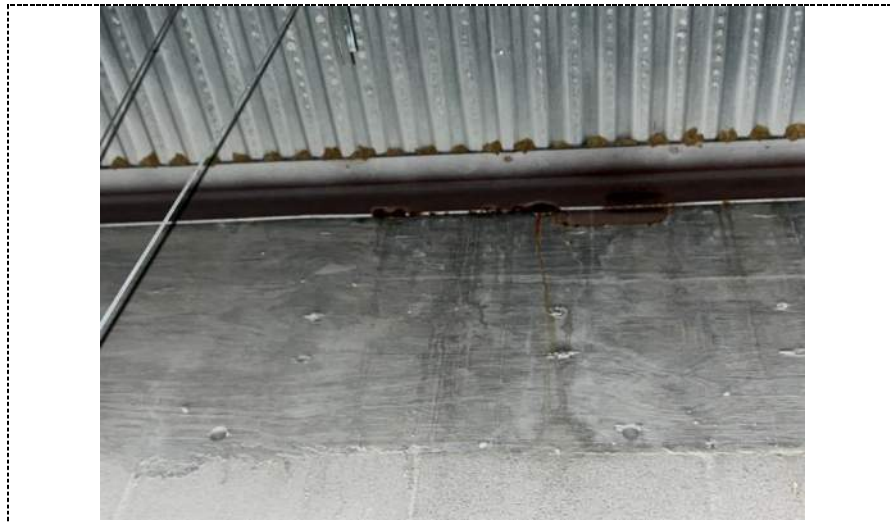
Photo 103 - Evidence of above ceiling roof leaks along parapet wall in Northwest classroom in North pod (stained ceiling tile below)- building 2.

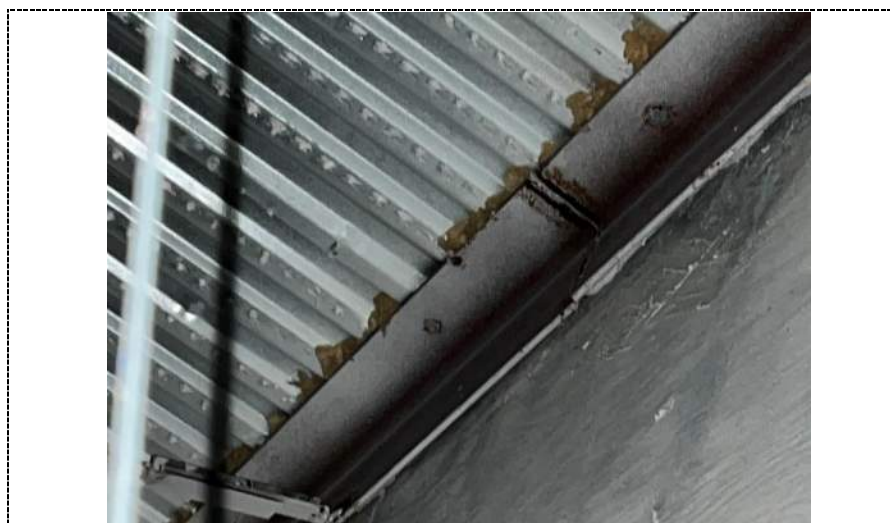
Photo 104 - Evidence of above ceiling roof leaks along parapet wall in Northwest classroom in North pod (stained ceiling tile below)- building 2.

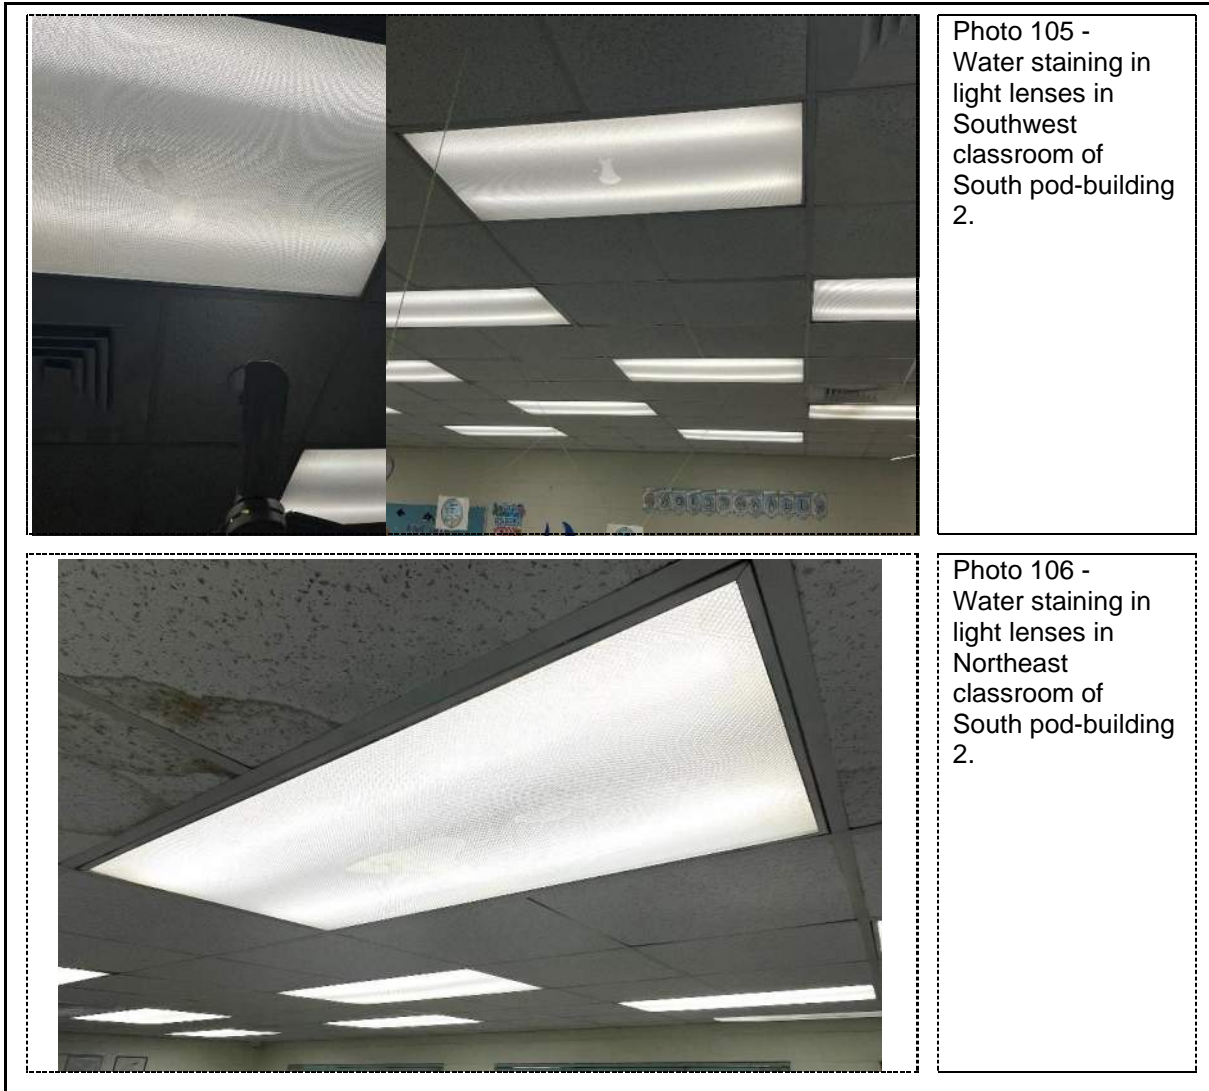
Photo 105 -
Water staining in
light lenses in
Southwest
classroom of
South pod-building
2.

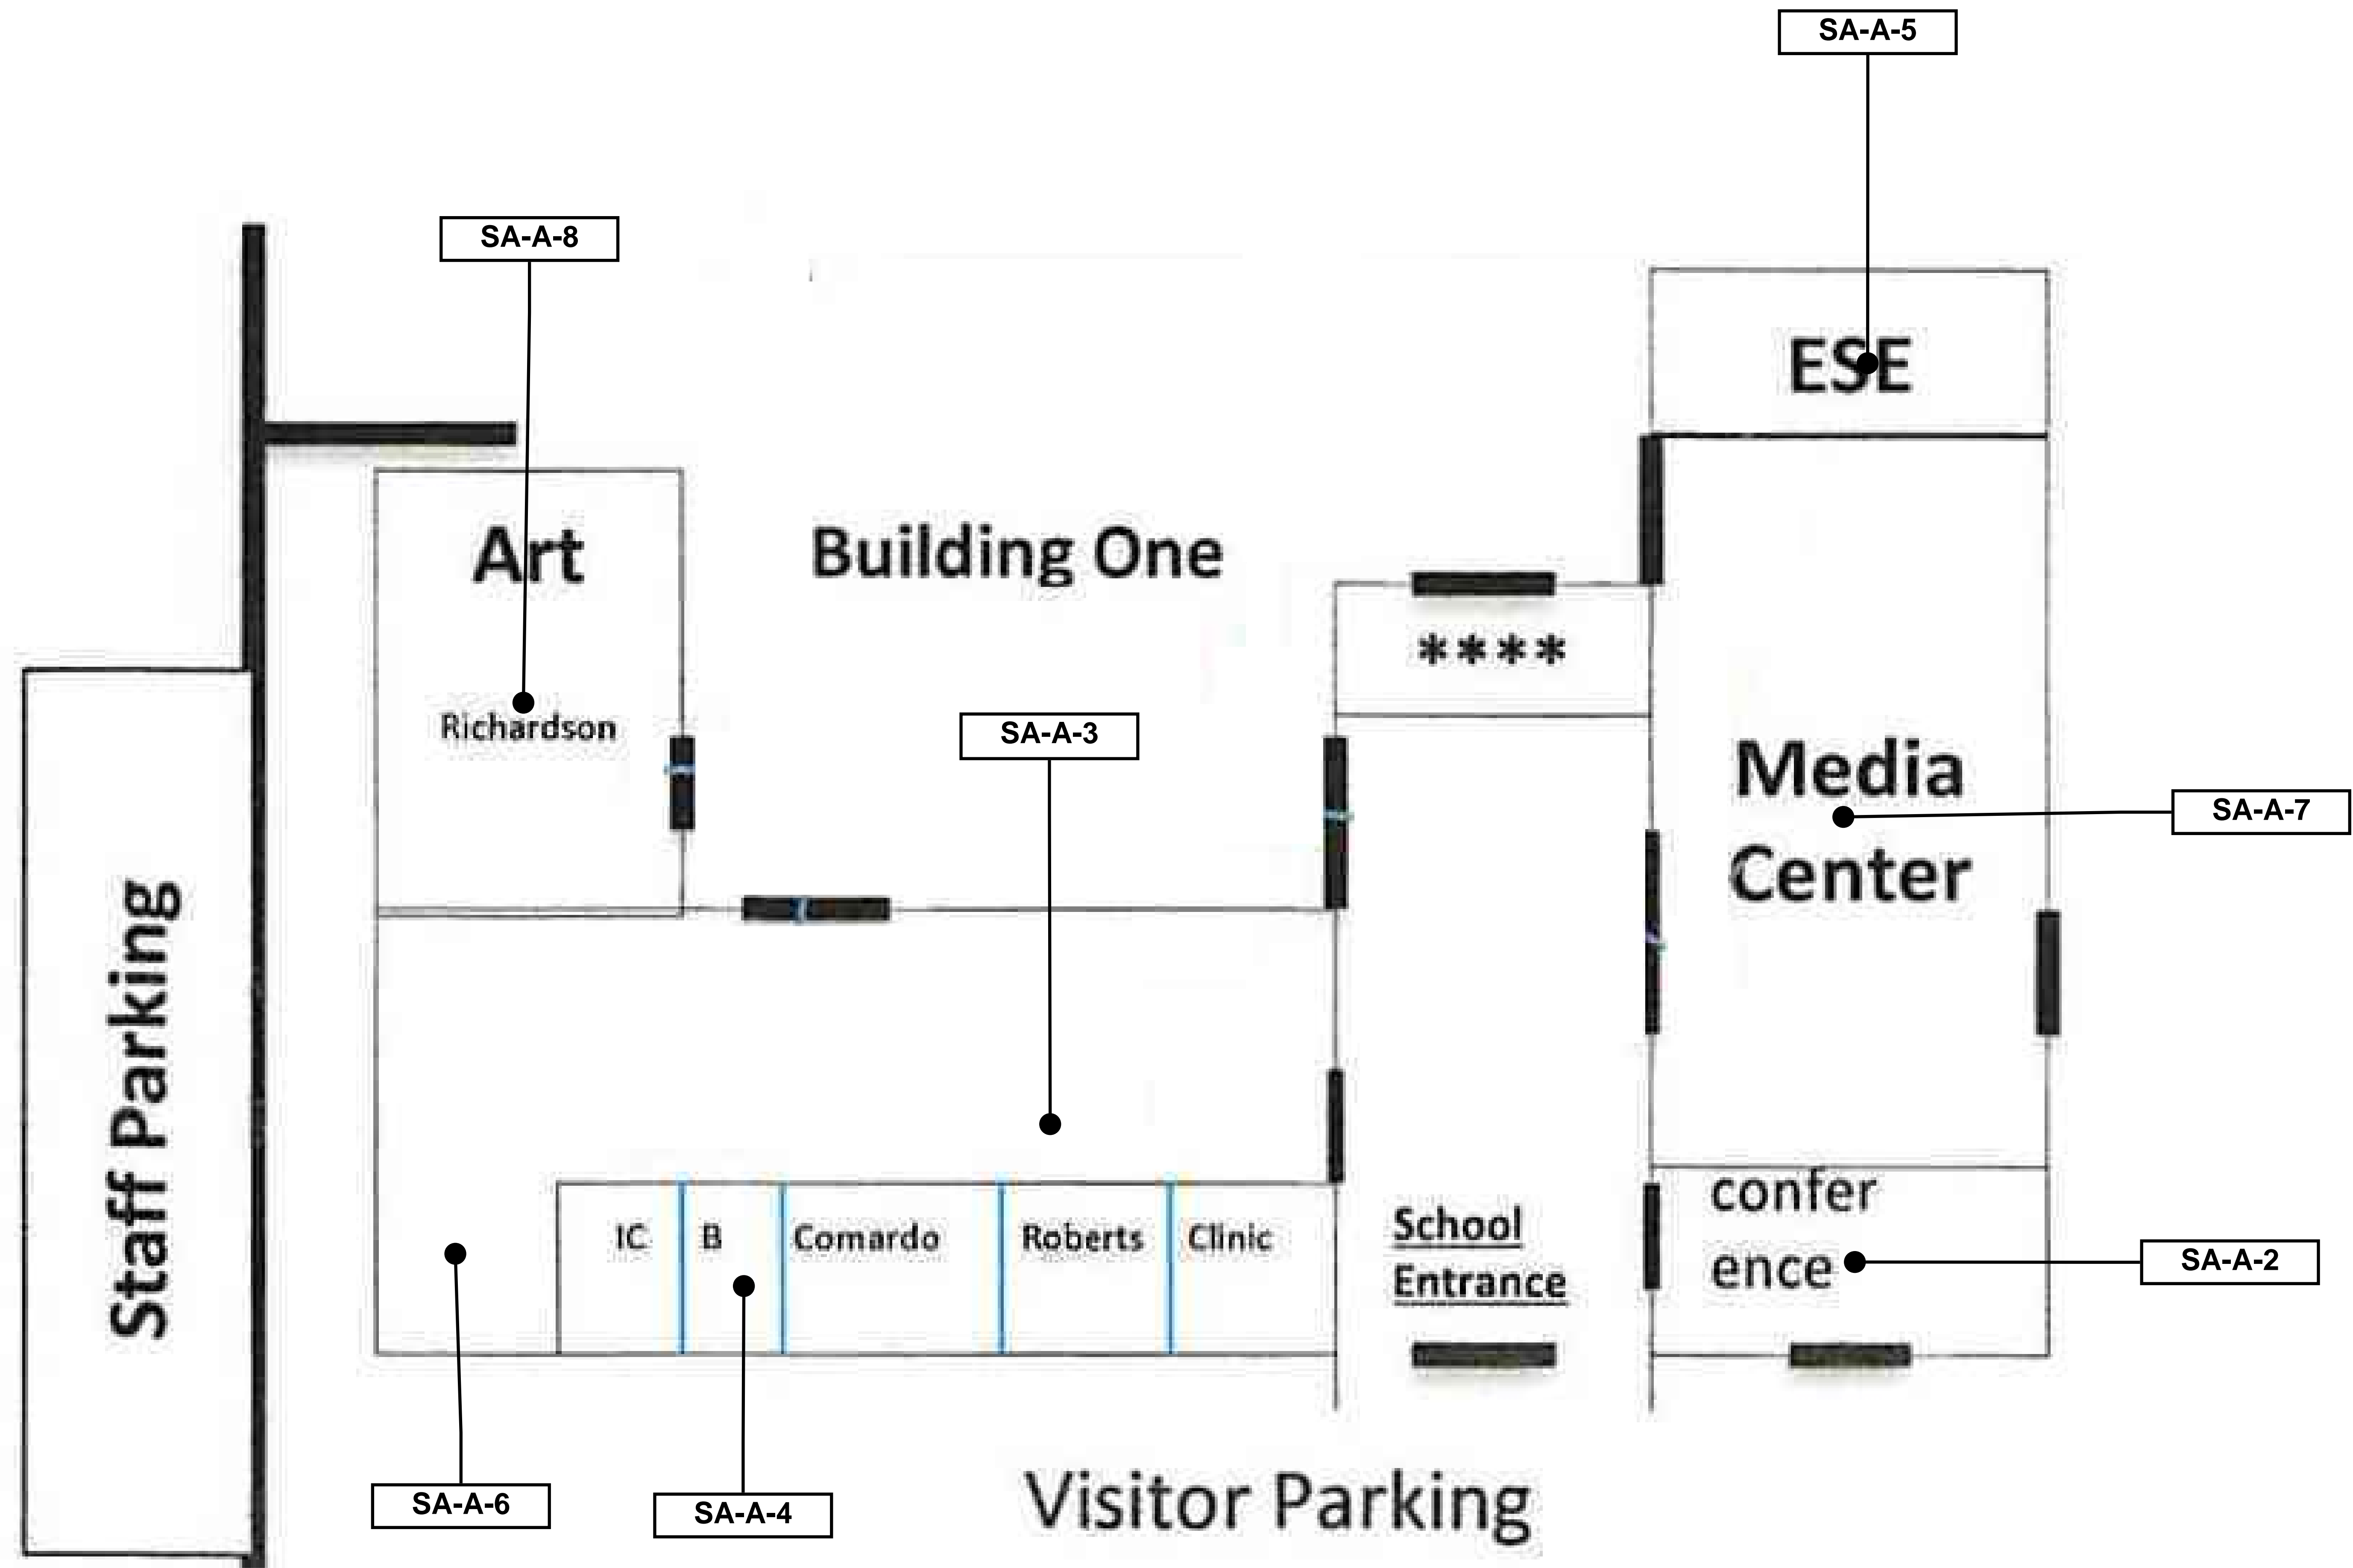
Samsula Academy
248 North Samsula Drive
New Smyrna Beach, Florida 32168

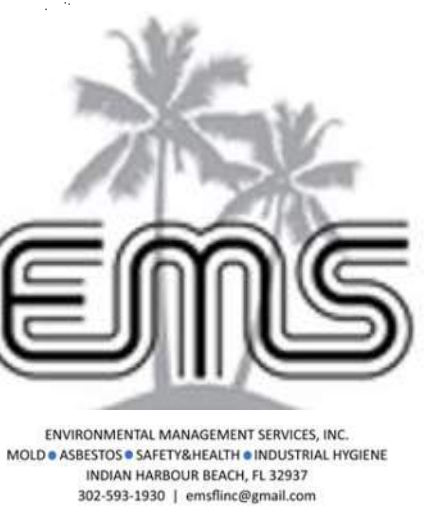
BUILDING 1 INDOOR AIR COMFORT PARAMETER MEASUREMENTS MAP

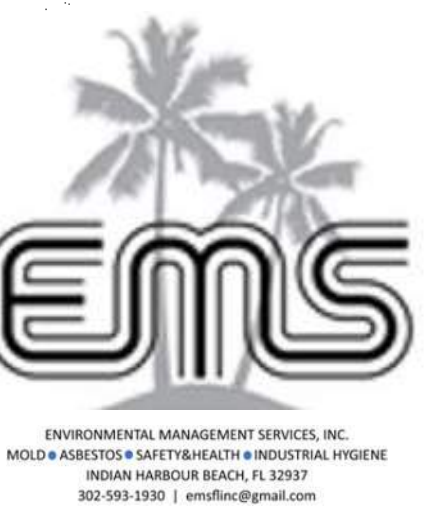
BUILDING 1 LIMITED MOISTURE MAP

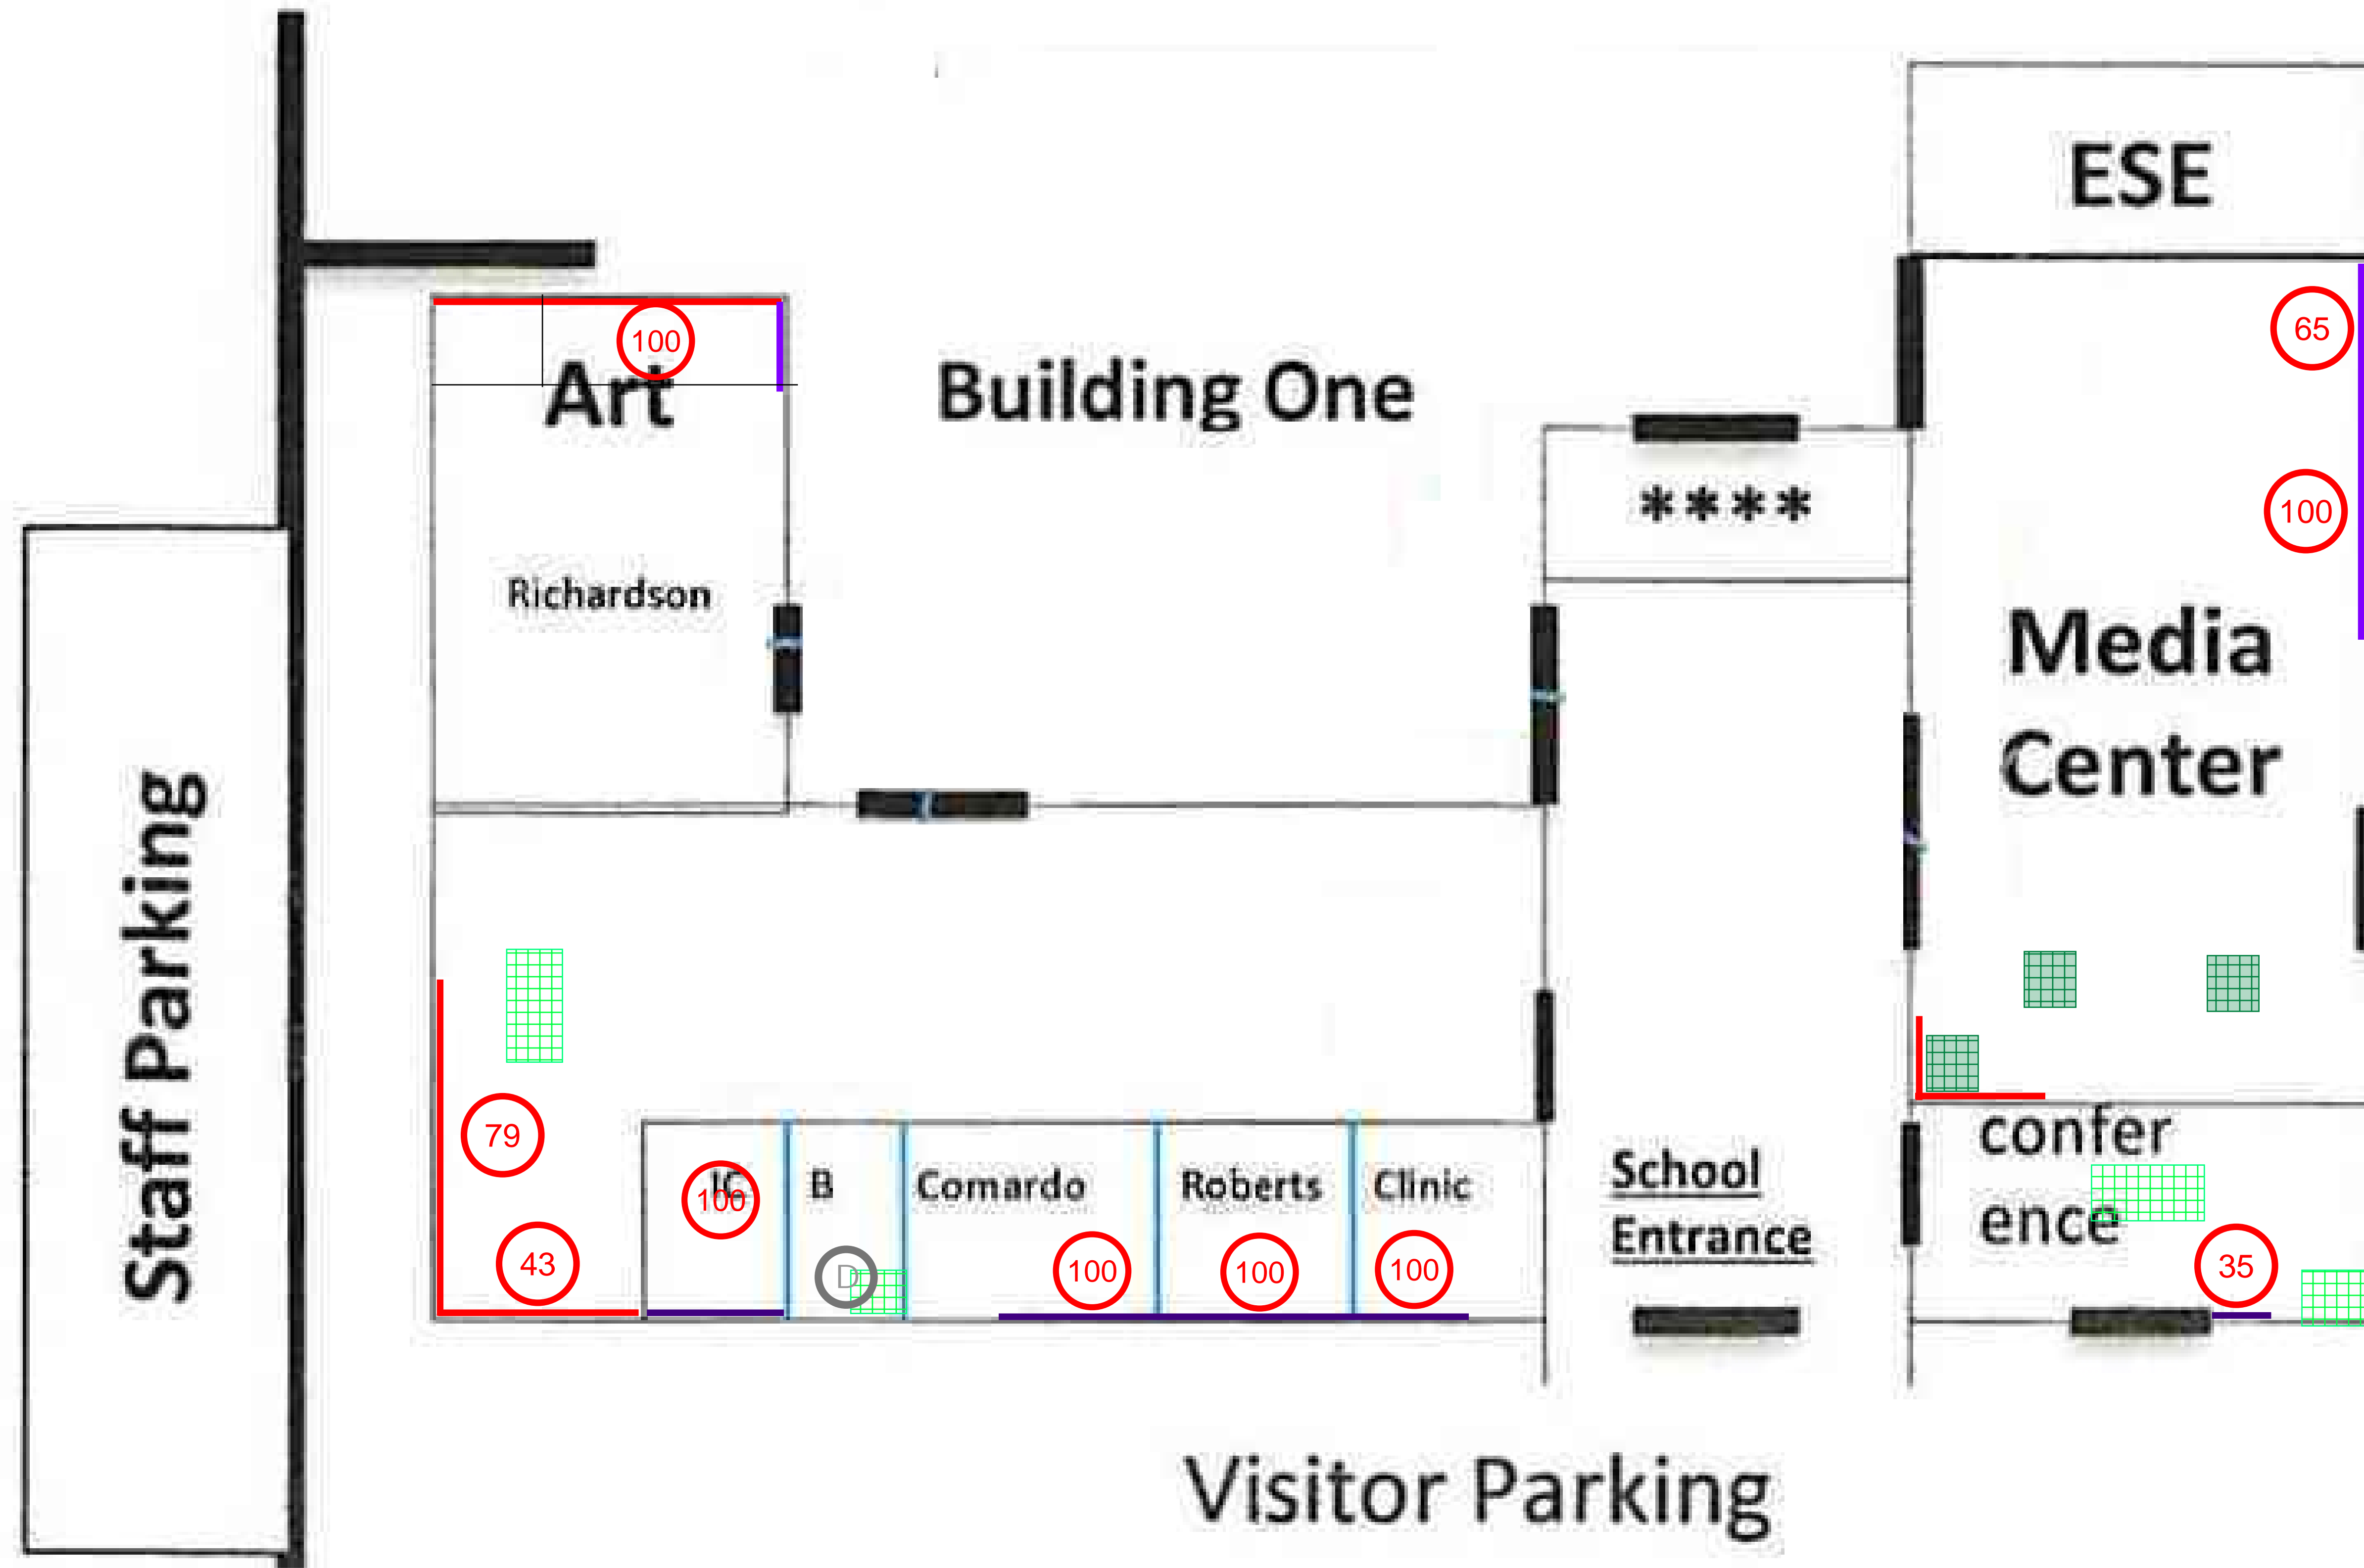
Samsula Academy
248 North Samsula Drive
New Smyrna Beach, Florida 32168
