LIMITED INDOOR AIR QUALITY (IAQ) and MICROBIAL ASSESSMENT REPORT

Project Location:

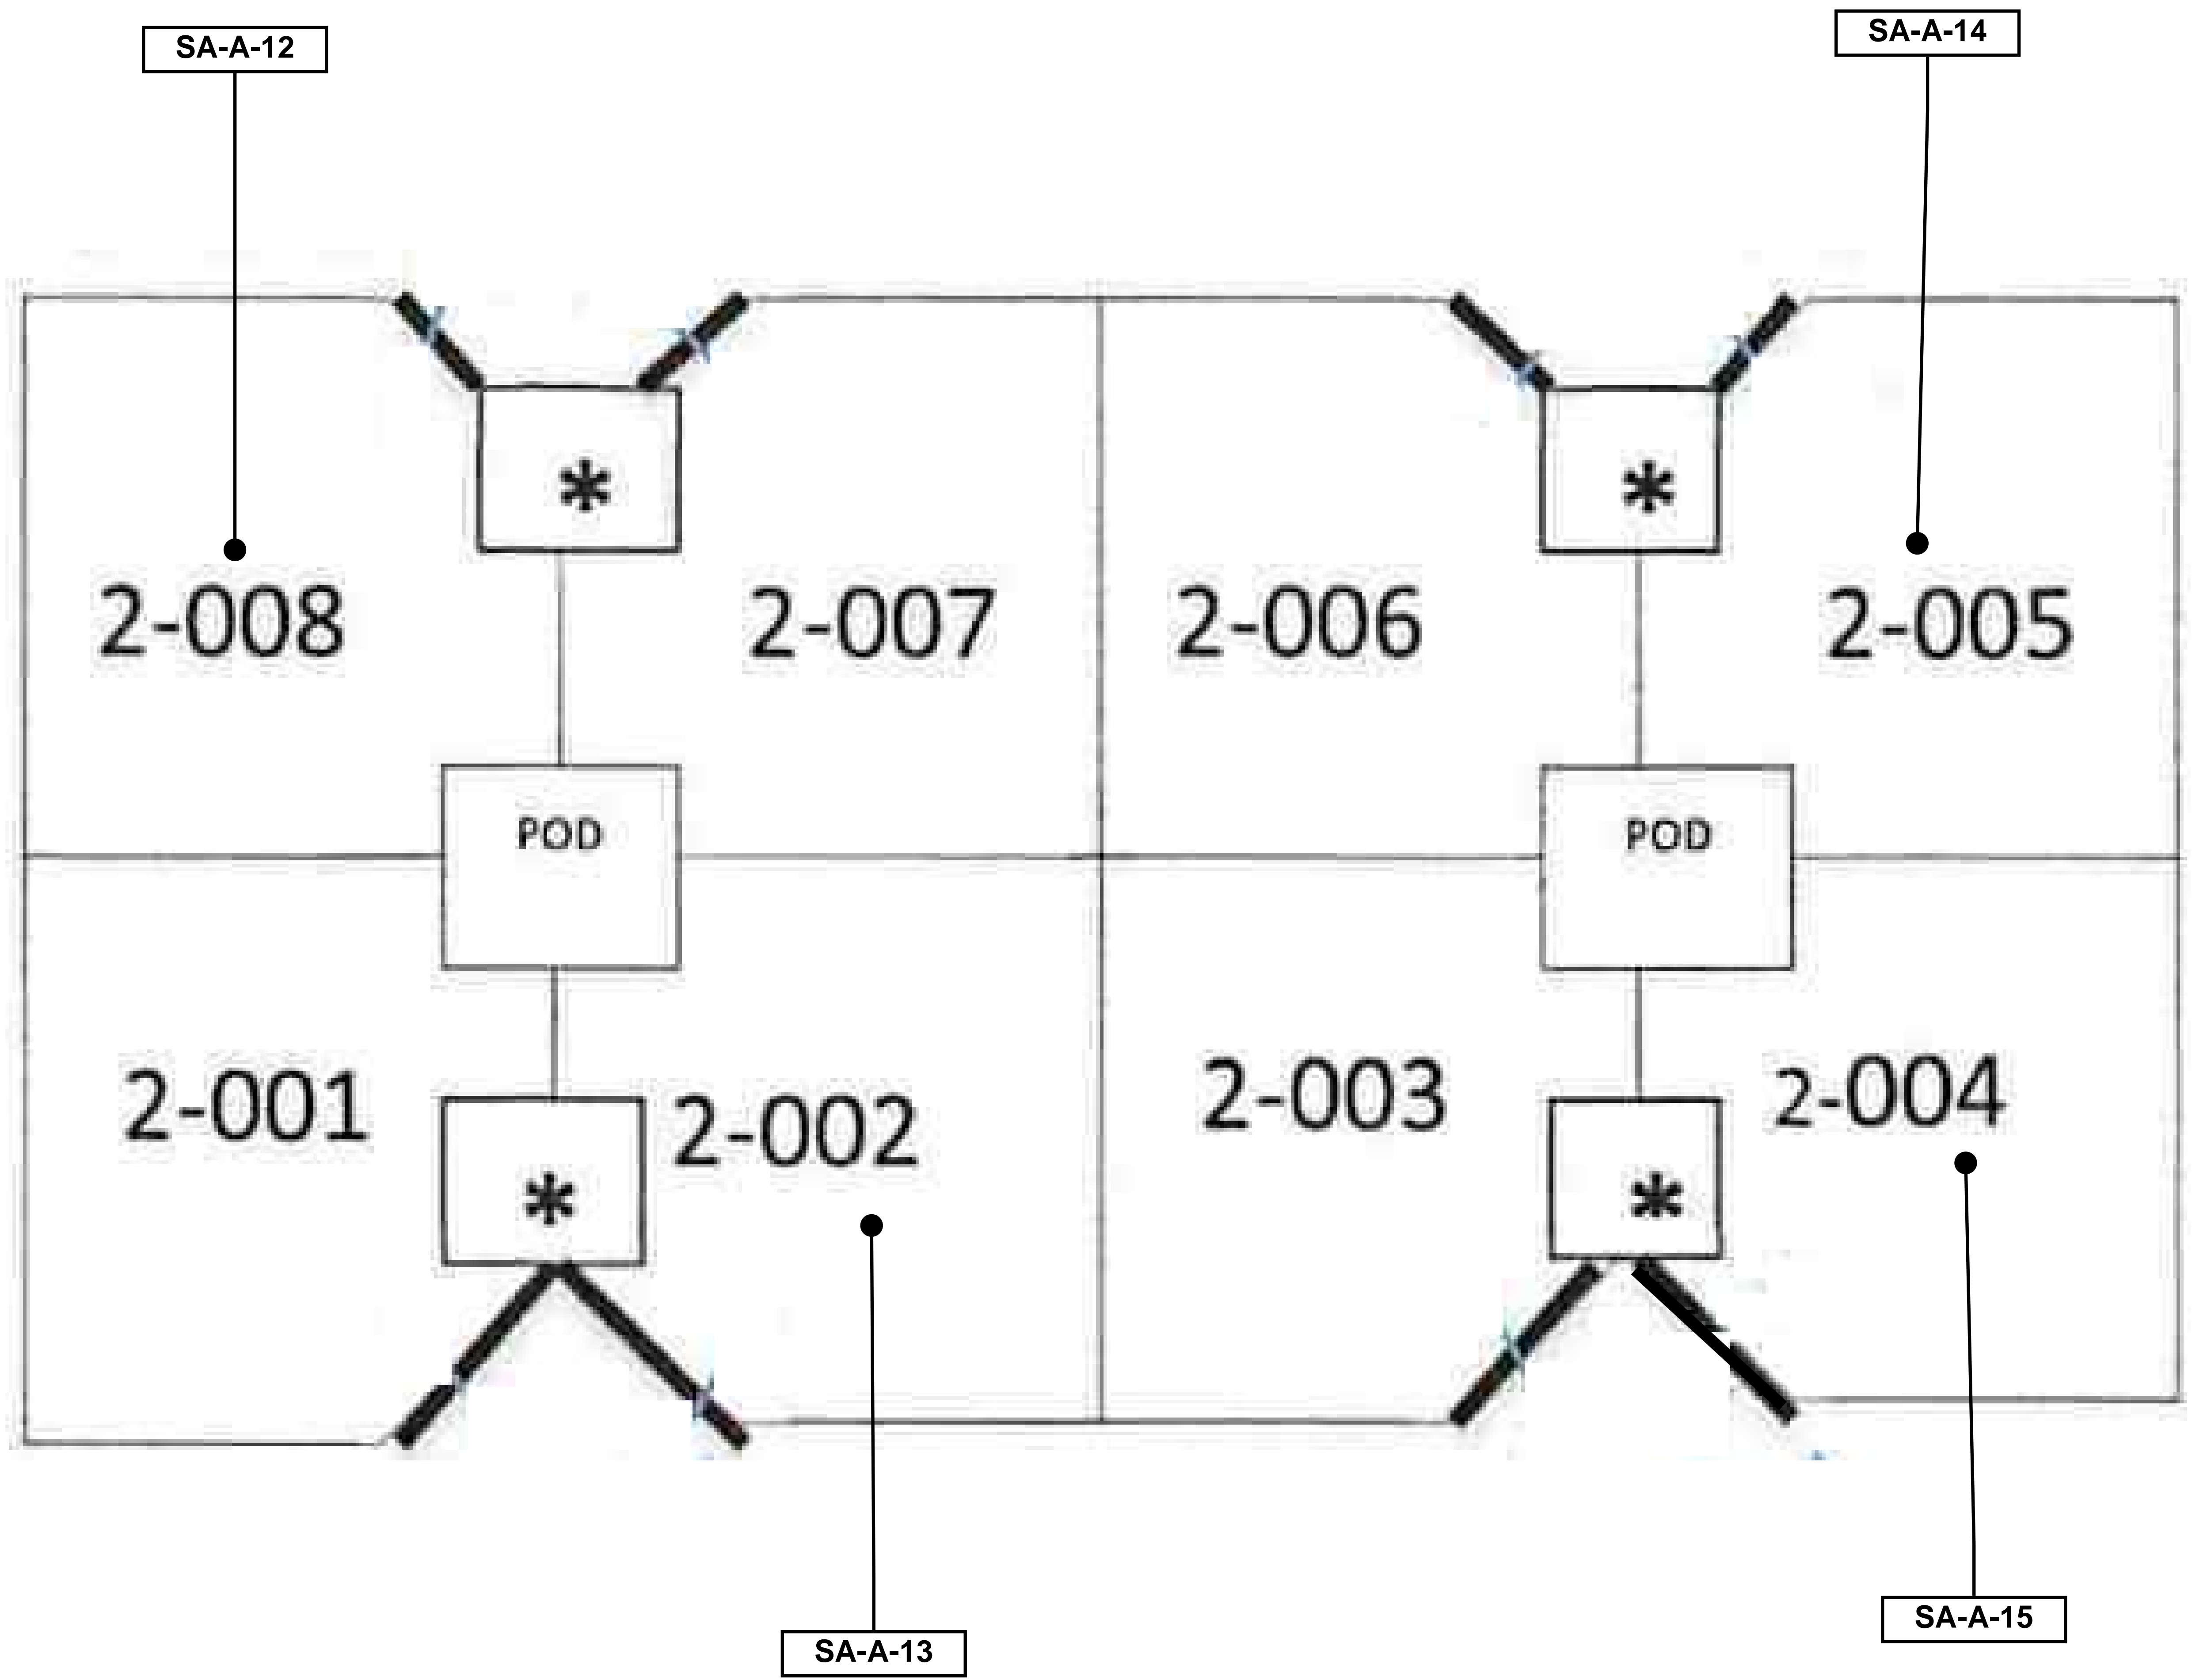
Samsula Academy
 248 North Samsula Drive
 New Smyrna Beach, Florida 32168

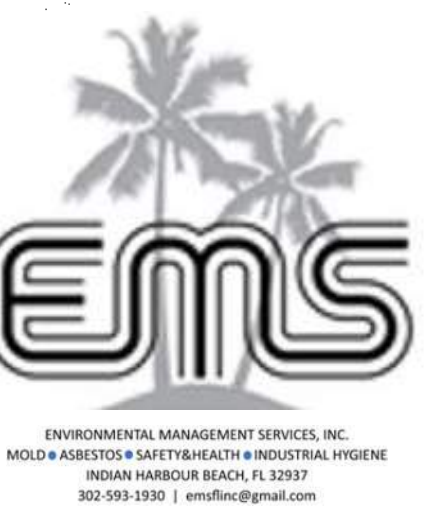
BUILDING 2 INDOOR AIR COMFORT PARAMETER MEASUREMENTS MAP

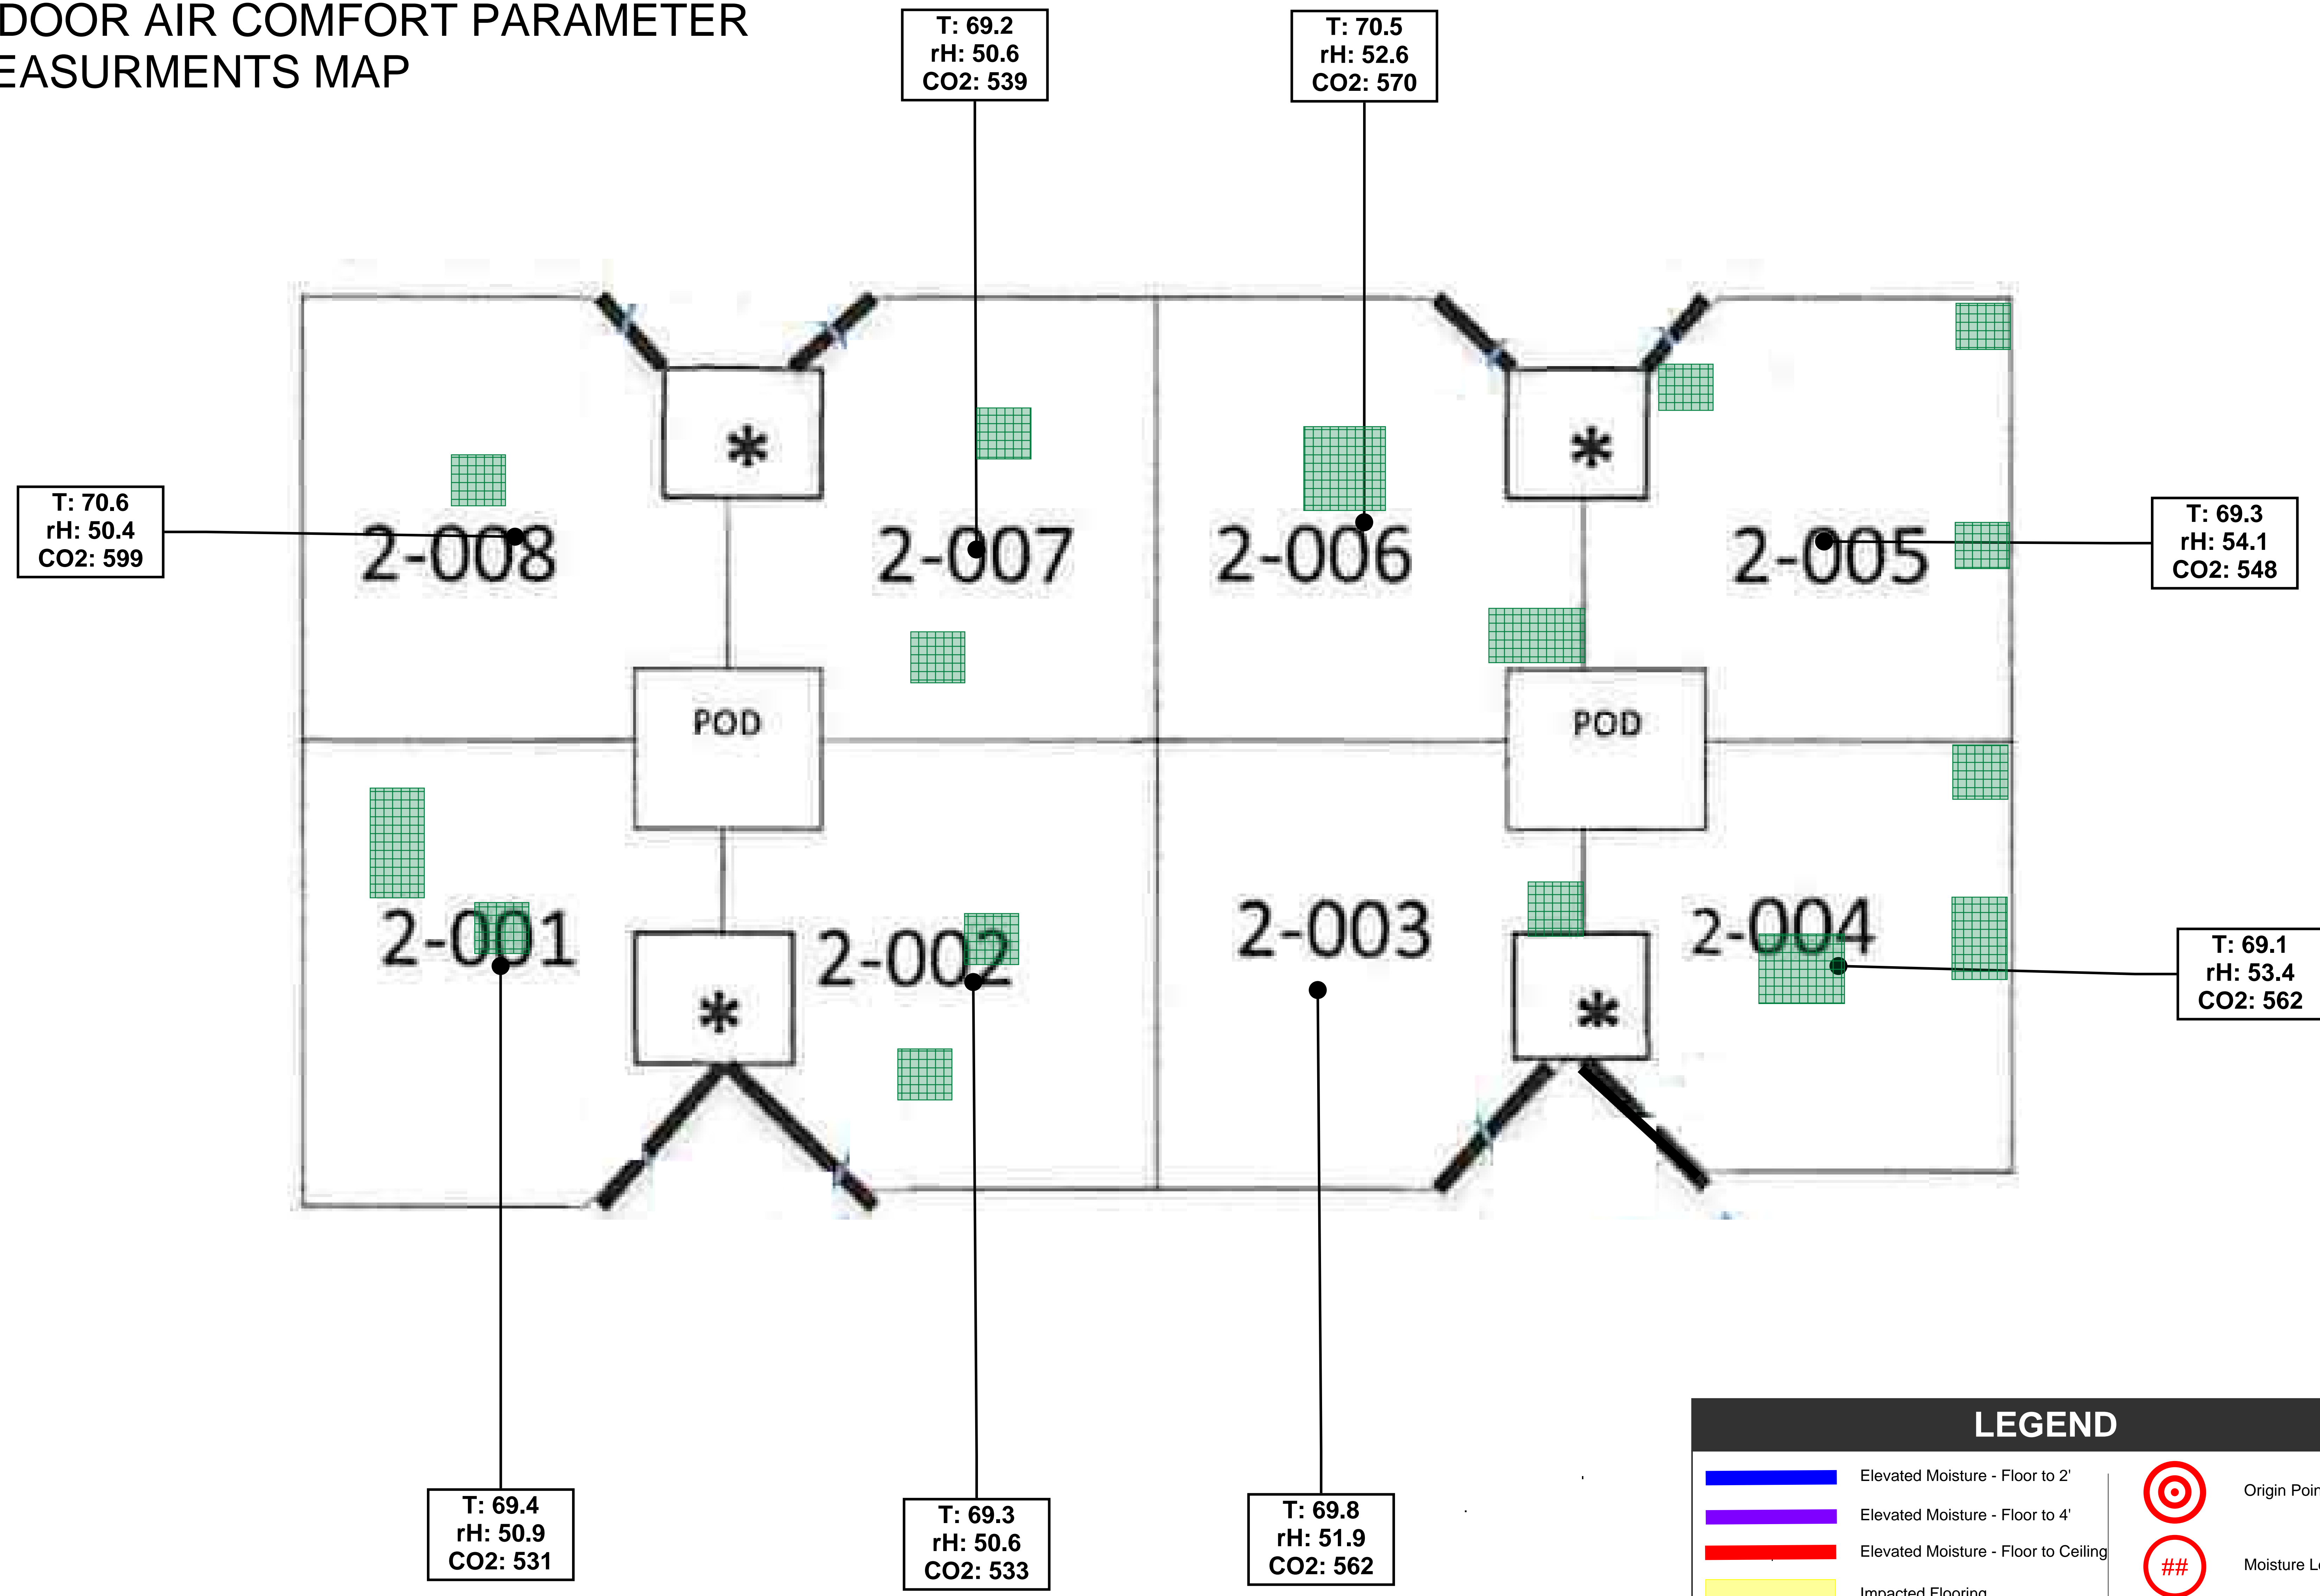
Samsula Academy
248 North Samsula Drive
New Smyrna Beach, Florida 32168

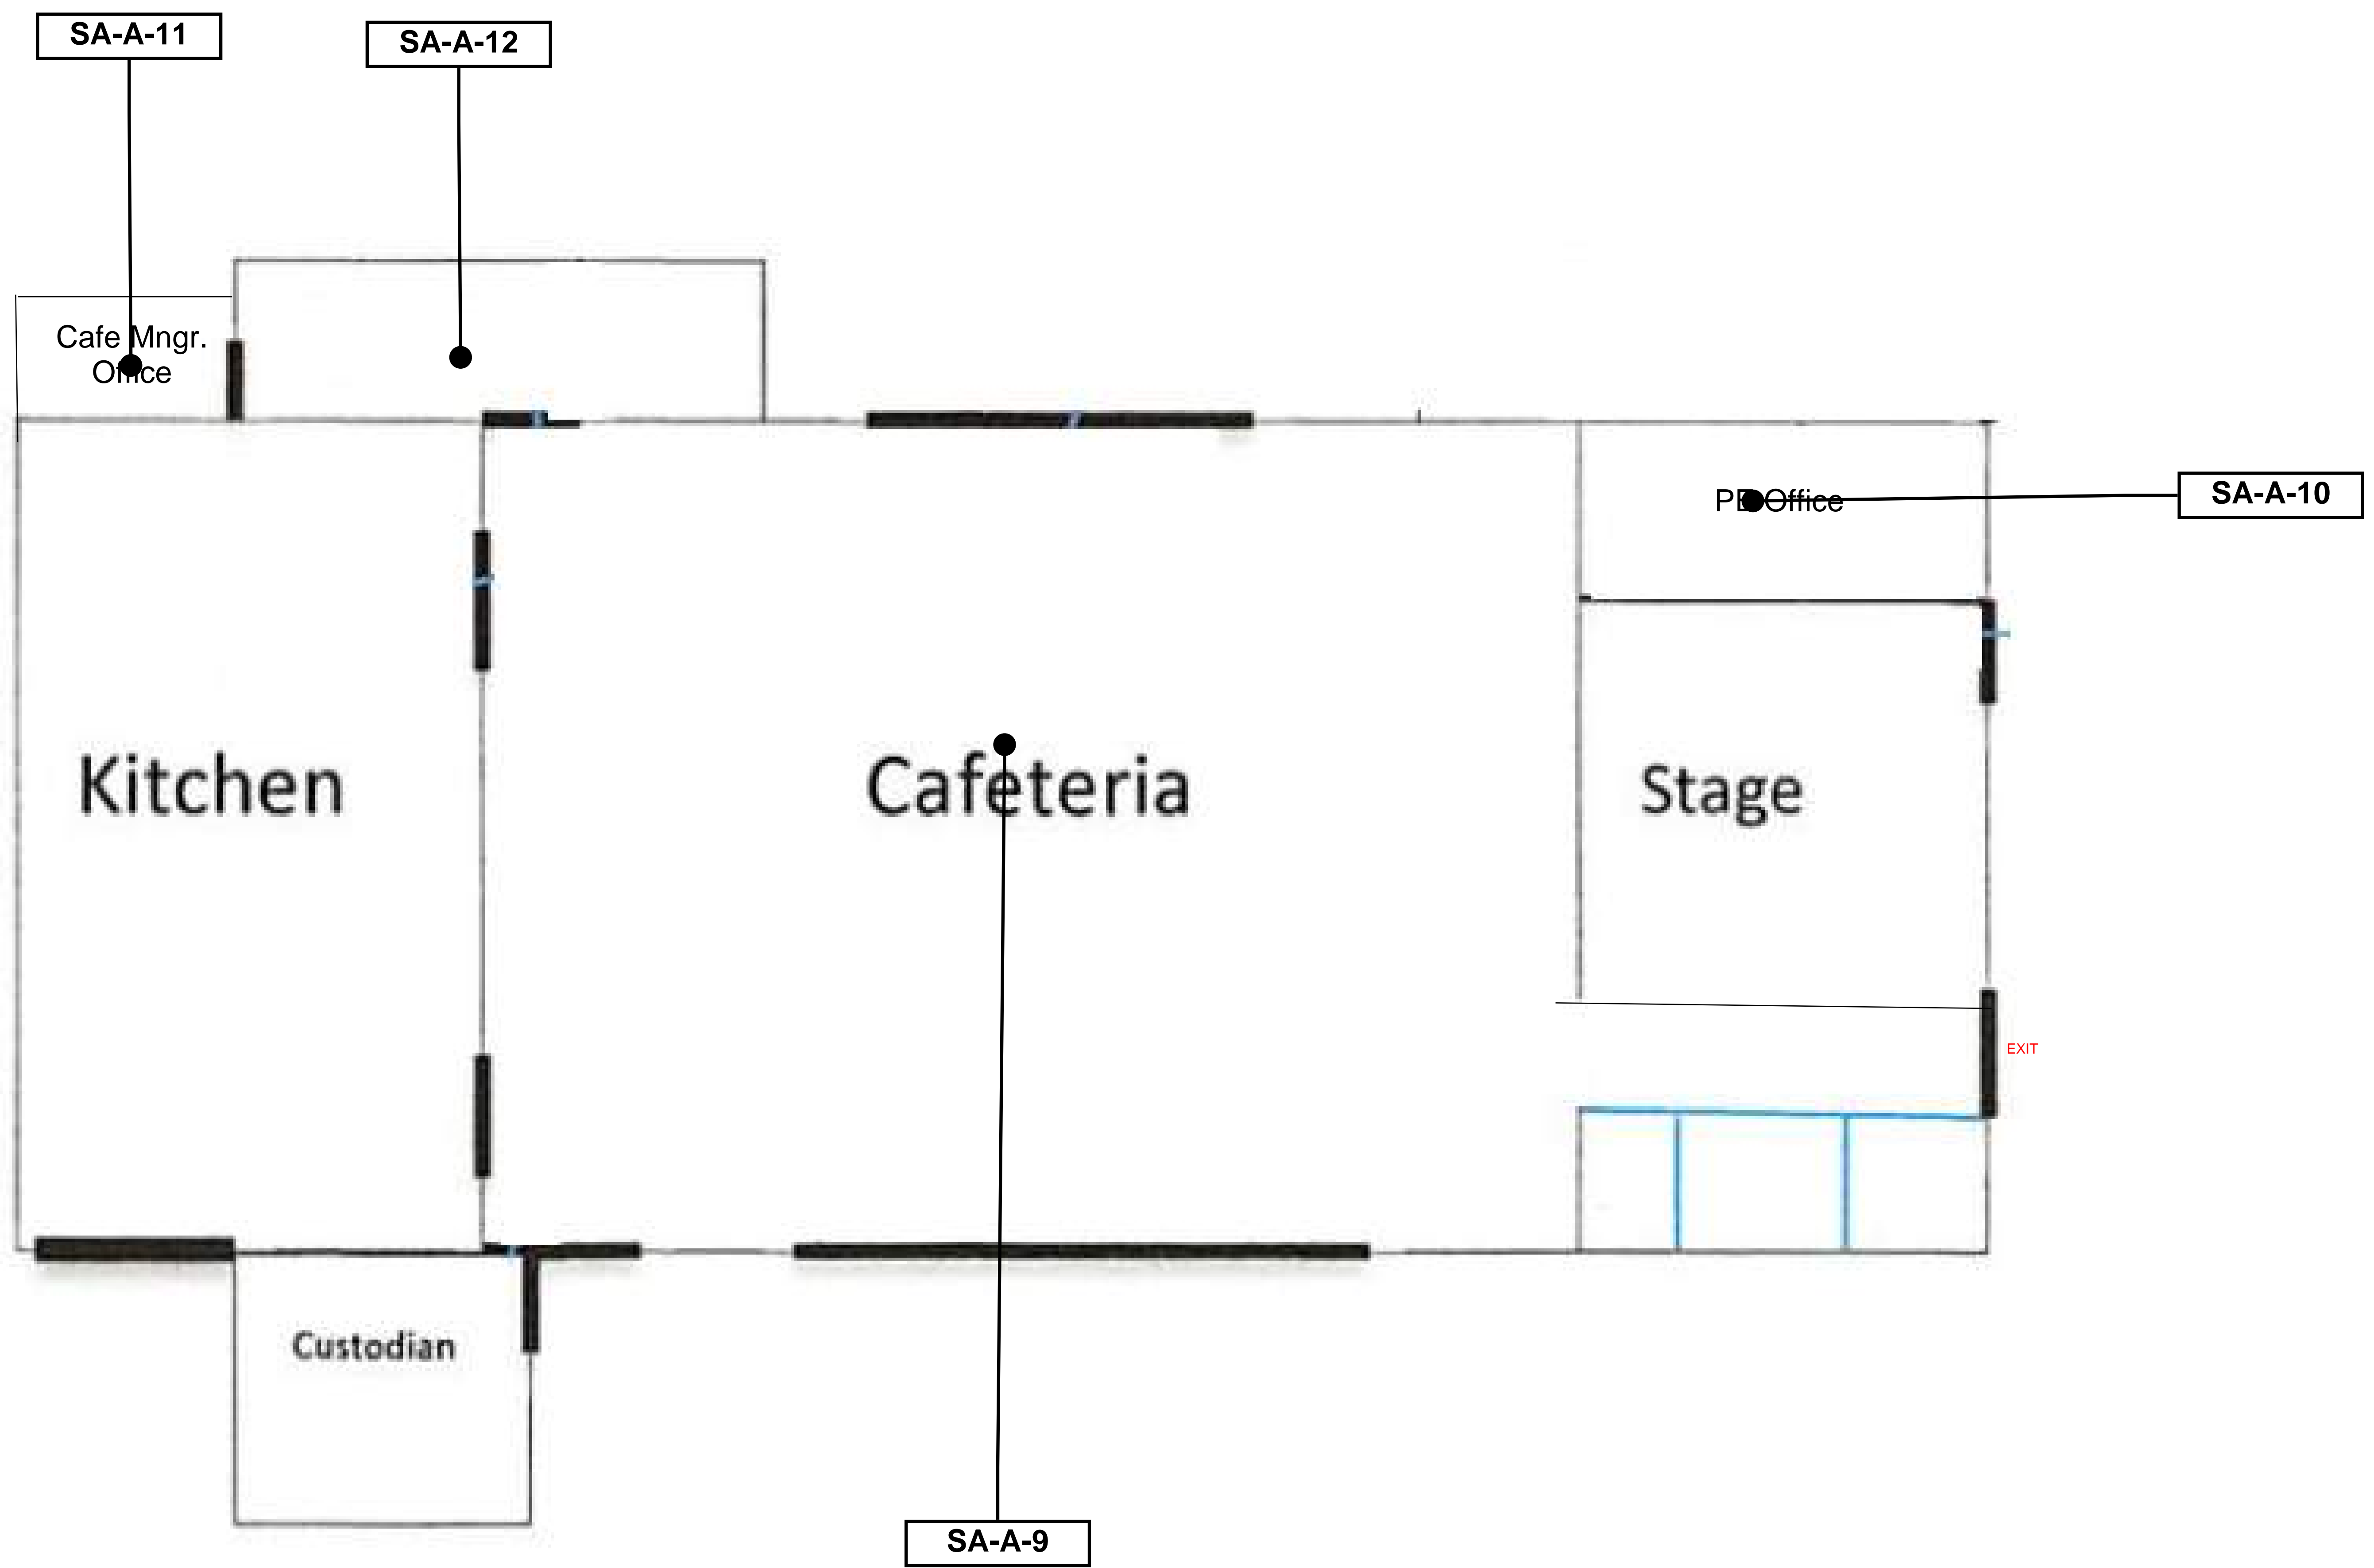
Samsula Academy
 248 North Samsula Drive
 New Smyrna Beach, Florida 32168

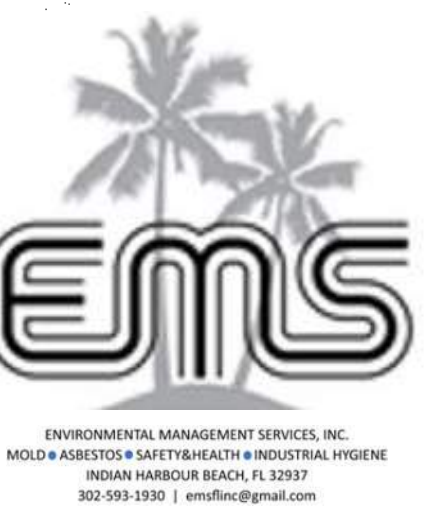
BUILDING 3 INDOOR AIR COMFORT PARAMETER MEASUREMENTS MAP

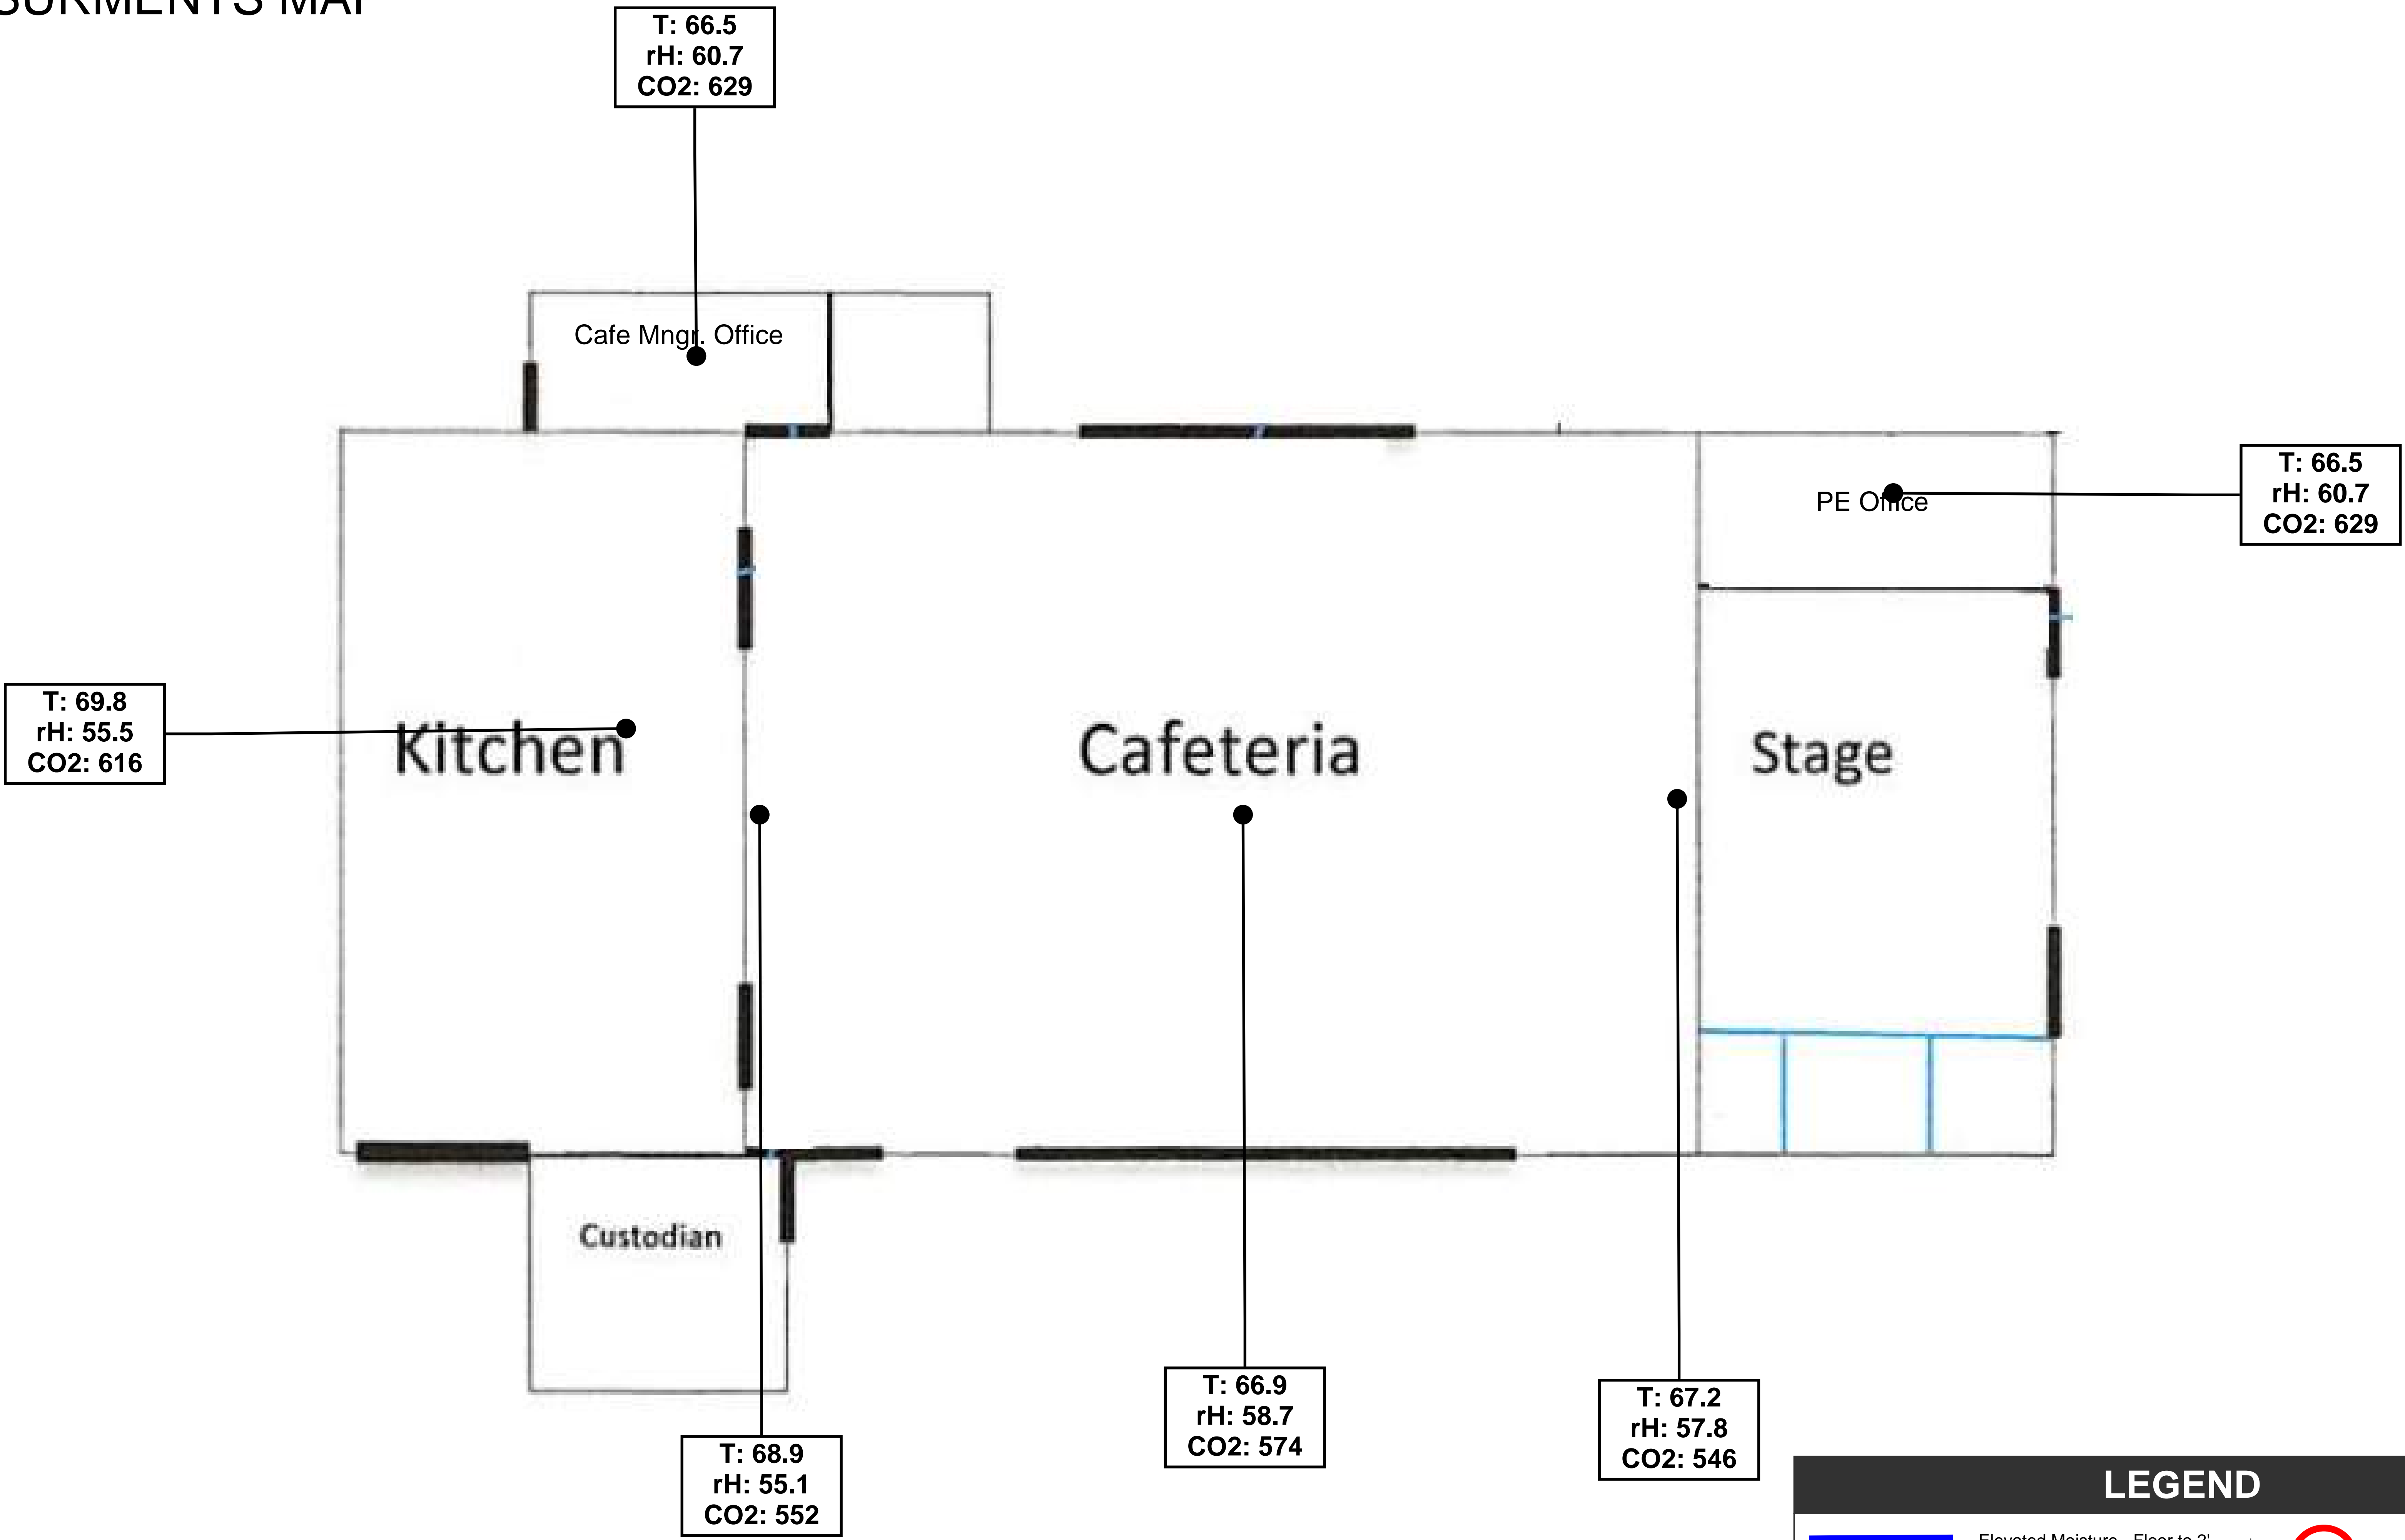
Samsula Academy
248 North Samsula Drive
New Smyrna Beach, Florida 32168

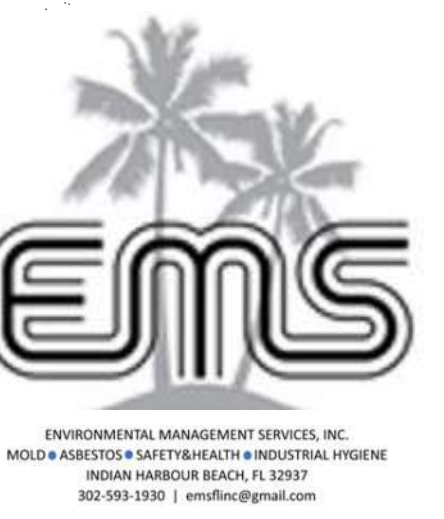
BUILDING 3 LIMITED MOISTURE MAP

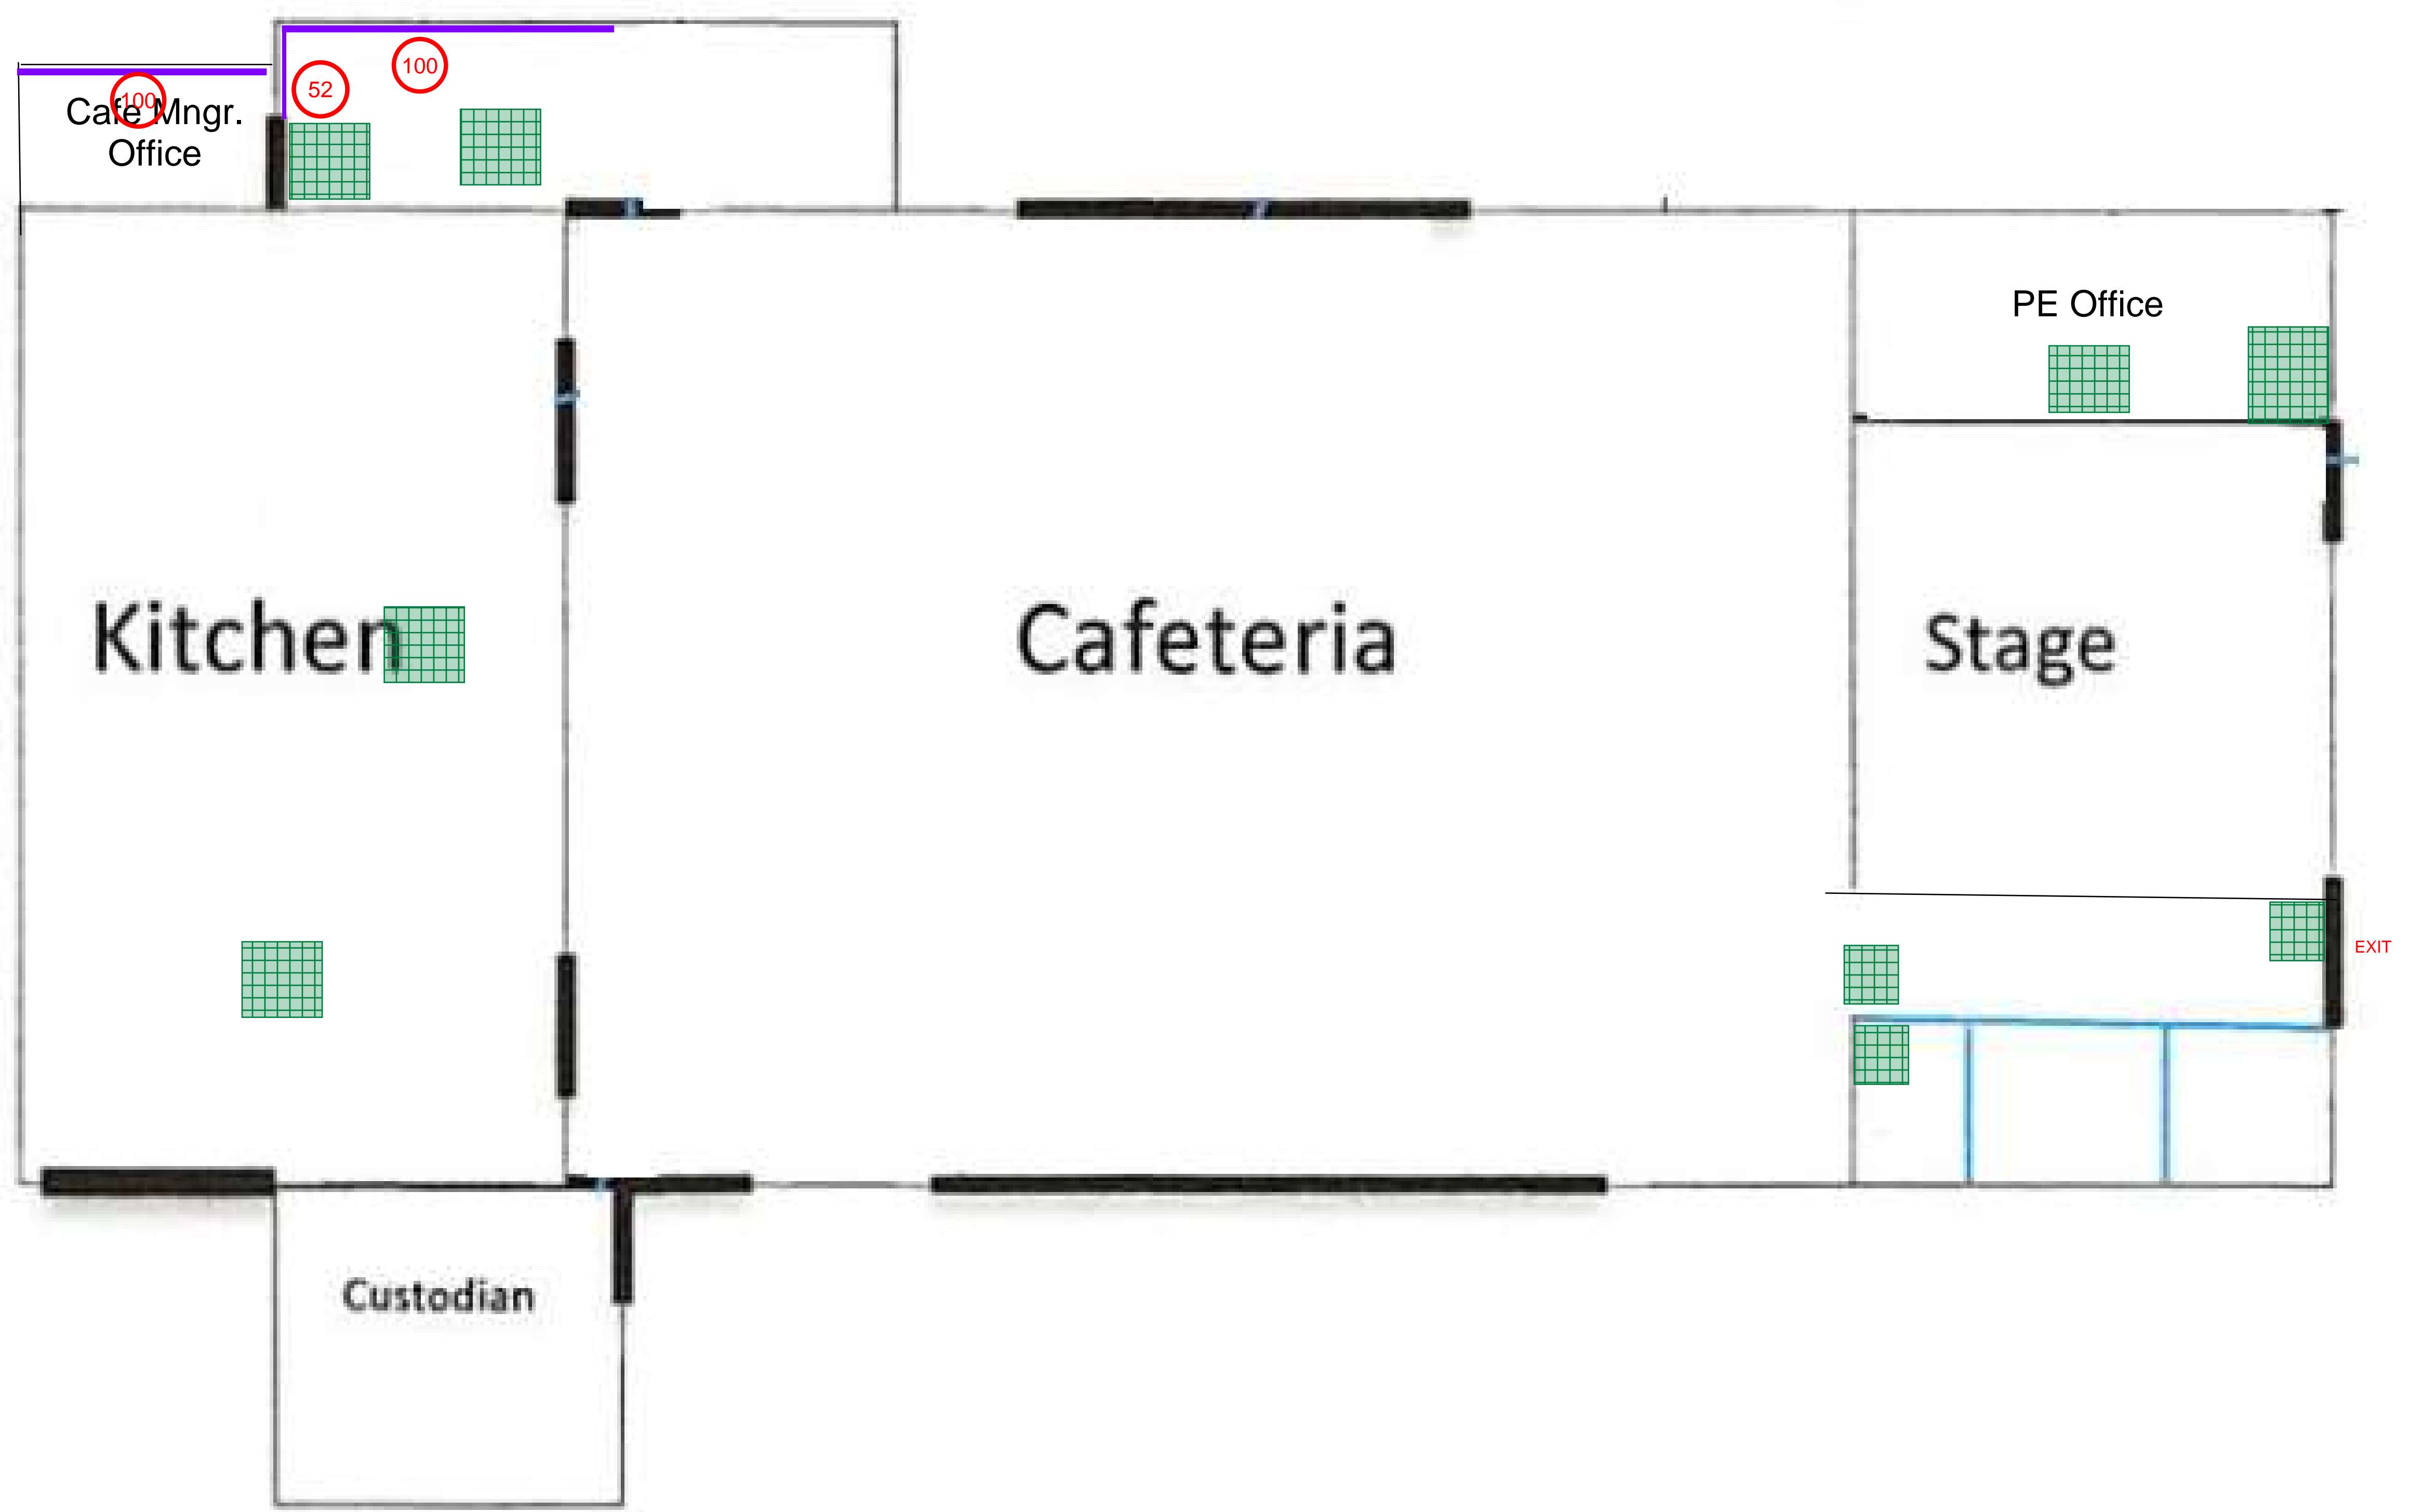
Samsula Academy
248 North Samsula Drive
New Smyrna Beach, Florida 32168

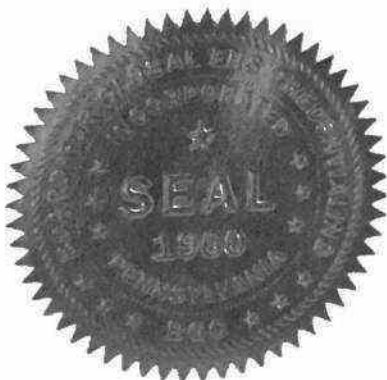
Board of Certified Safety Professionals
